Wake Transit Plan

Equipment Assessment

TASK 4.2 – EQUIPMENT ASSESSMENT

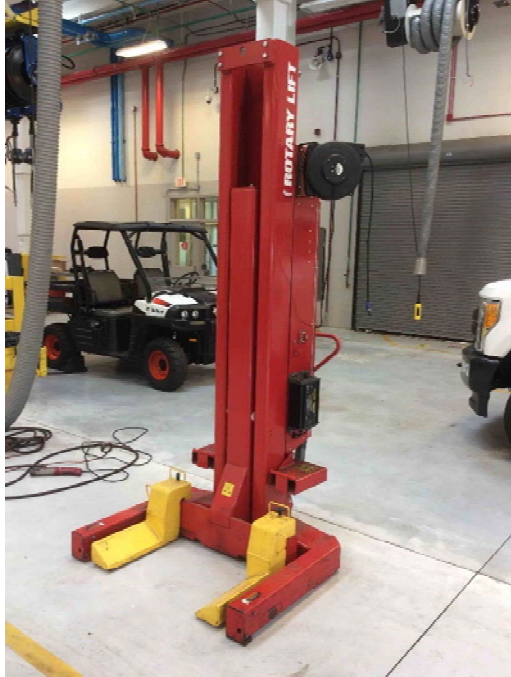
Item Number	Element	Description	Observation	Recommendation	Score
Maintenance Bays					5
GR.001	Portable Vehicle Lifts	Rotary 18,000 pound capacity, wireless portable lifts	All portable lifts were installed when the facility was constructed and function properly.	Clean weekly and store the lifts properly when not in use to maintain the integrity of the lifts.	5
GR.002	In-ground Vehicle Lifts	Rotary MOD 30 two-post lift, 60,000 pound capacity	All in-ground lifts were installed when the facility was constructed and function properly.	Perform recommended service as required by the manufacturer to ensure the life expectancy.	5
GR.003	Lubrication Reel Banks	Graco fluid reel banks for distribution of lubricants to the repair bays	No visible damage or leaks from dispensers. Piping was not installed properly around the lighting.	Perform recommended service as required by the manufacturer to ensure the life expectancy.	5

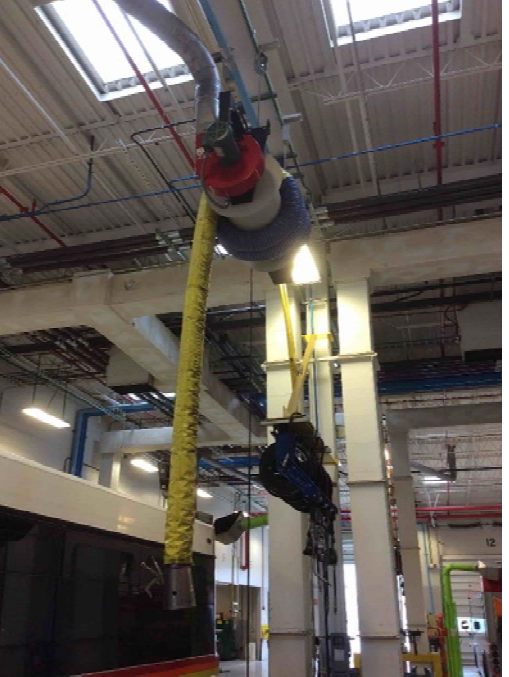
GR.004	Vehicle Exhaust Reels	Motor operated vehicle exhaust reels individually ducted to the exterior	No visible damage to the reel or hose. Exhaust port adapter units were purchased for different port designs.	Perform recommended service as required by the manufacturer to ensure the life expectancy.	5
GR.005	Fluid Evacuation Pumps	Waste Oil and Waste Coolant pumps to send waste fluid to the waste fluid tanks	No visible damage to the pumps, hoses, or fittings.	Perform recommended service as required by the manufacturer to ensure the life expectancy.	5
GR.006	Oil Filter Crusher	Oil filter crusher to compact large oil filters after buses are serviced	No visible damage to the unit.	Perform recommended service as required by the manufacturer to ensure the life expectancy.	5
Lower Level Work Area (LLWA)					5
GR.007	Mobile Man Lift	Portable scissor lift on a track for accessing the bottom of a bus/vehicle when being serviced	No visible damage or apparent functional issues. Equipment is rarely used.	Perform recommended service as required by the manufacturer to ensure the life expectancy.	5

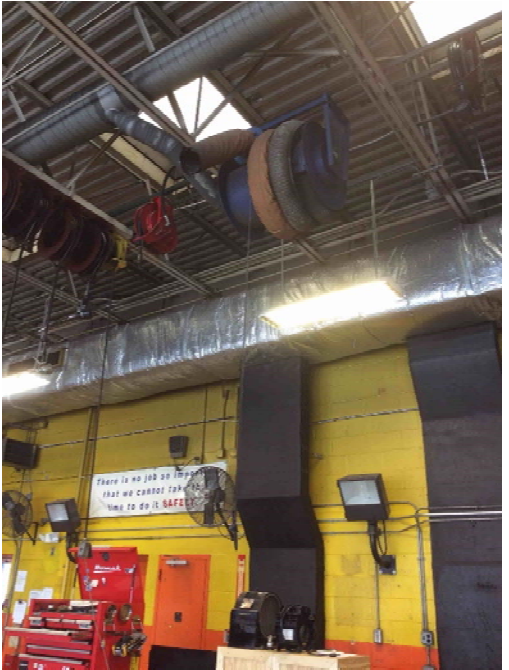
Item Number	Element	Description	Observation	Recommendation	Score
Maintenance Bays					3
GW.001	Four Post Lifts	Rotary four-post surface mounted lifts, 18,000 pound capacity	All surface mounted lifts were recently installed in replacement of the in-ground lifts.	Perform recommended service as required by the manufacturer to ensure the life expectancy.	5
GW.002	In-Ground Lifts	Hydraulic powered in-ground lifts	All in-ground lifts have been decommissioned.	Remove and fill voids.	1
GW.003	Lubrication Reel Banks	Fluid reel banks for distribution of lubricants to the repair bays	Reel banks are not used. Technicians only use the air reel. All fluids are stored in 55 gallon drums.	Replace with a fluid distribution system and new reel banks.	1
GW.004	Vehicle Exhaust Reels	Spring operated vehicle exhaust reels	Exhaust reels are from the original building design for fixed route buses. Reels are unused by WCTS.	Remove and replace with new exhaust reels with modern design features.	1

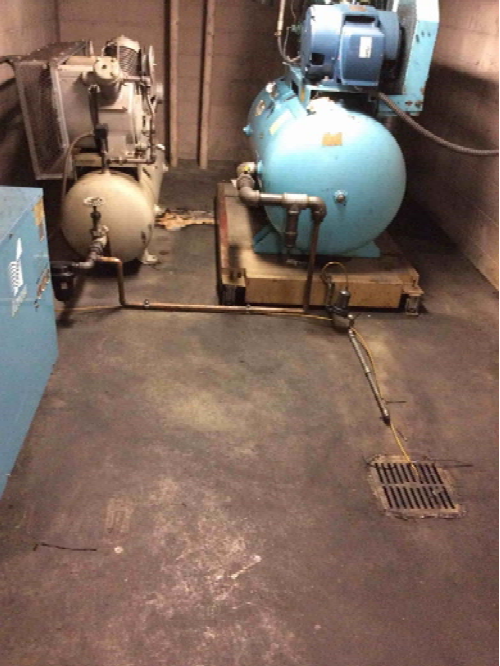
Tire Storage is lacking racks specifically designed for tires. There is a total of two storage racks for a storage need of 50 tires. Most of the tires are on the ground, and there is no separation between new and used tire storage. The overall equipment condition score is 2 because the storage systems in place are poor approach for tire storage.

Tire Storage					2
GW.015	Tire Storage Racks	Light duty rack systems used as tire storage racks	Racks are not specifically designed for tire storage. Not an adequate amount of racking for tires.	Replace with racks designed for light tire storage.	2
Compressor Room					3
GW.016	Air Compressors	Duplex air compressors for building supply.	Compressors are from the original facility, having been serviced for when the building was repurposed.	Perform recommended service as required by the manufacturer to ensure the life expectancy.	3
Fluid Storage					4
GW.017	Oil Filter Crusher	B.J. Enterprises oil filter crusher for compacting used oil filters after vehicles are serviced	In good condition; well maintained.	Perform recommended service as required by the manufacturer to ensure the life expectancy.	5
GW.018	Windshield Washer Fluid Tank	Polyethylene tank for storing windshield washer fluid with a dispenser	In good condition with proper signage. Could be dispensed through a fluid reel bank.	Perform recommended service as required by the manufacturer to ensure the life expectancy.	5

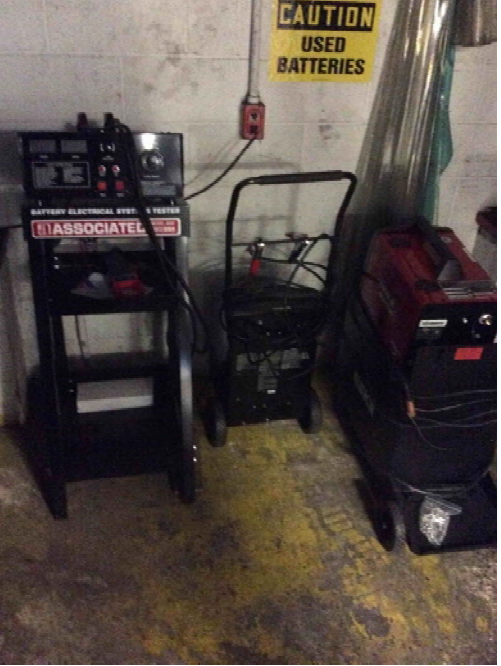
The Battery Charging/Storage area does not utilize specialty equipment typically supplied for charging batteries. Instead of using battery benches, batteries are stored on unsecure ply wood that is rested on CMU block. The charger is in good condition, however the charging bar is not securely fastened to the wall. The overall condition of equipment is scored as a 3 for the Battery Storage/Charging room.

Battery Storage/Charging					3
GW.022	Battery Tables	Dedicated areas for batteries to be charged	Battery benches are not effective. Constructed of plywood across CMU block.	Replace with benches deigned for battery storage/charging.	2
GW.023	Battery Charger	Battery charger with a bar for charging multiple batteries	Charger is new but not installed properly. The battery bar is not securely fastened to the wall.	Install correctly. Perform recommended service as required by the manufacturer to ensure the life expectancy.	4
Wash Bay					4
GW.024	High Pressure Washer	Landa hot water, high pressure washer for manual washing of vehicles	No visible damage or apparent functional issues to the wash unit. No holder for the wand; hose and wand is on the ground between washes.	Perform recommended service as required by the manufacturer to ensure the life expectancy.	4
Fuel Lane					1
GW.025	Fuel Lane	Old fuel lane from GoRaleigh operations	None of the fuel equipment is used. In-ground tanks have been emptied and decommissioned.	Leave tanks in place to reduce project cost and environmental concerns associated with tank removal.	1

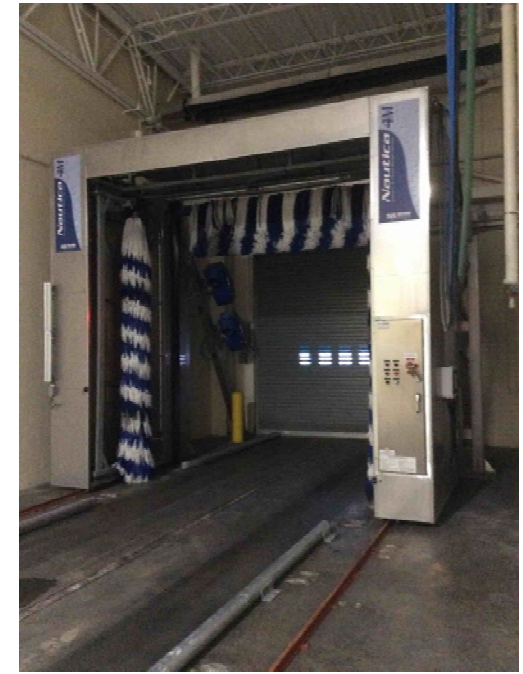
GT.035 – Gantry Bus Washer

The equipment located within the Wash bay is now in excellent condition, due to the replacement of the automated drive through washer with a new automated Gantry bus washer. A new DEF distribution system and storage tank was also recently installed. Due to these upgrades, the overall equipment score for the Wash Bay is 5. The recommendation for this area is to perform regularly scheduled service required by the manufacturer to sustain the lifespan of the equipment.
