# WILDLIFE CROSSING STUDY

Cape Fear River Basin

White Oak Creek at N.C. 540 (2026)

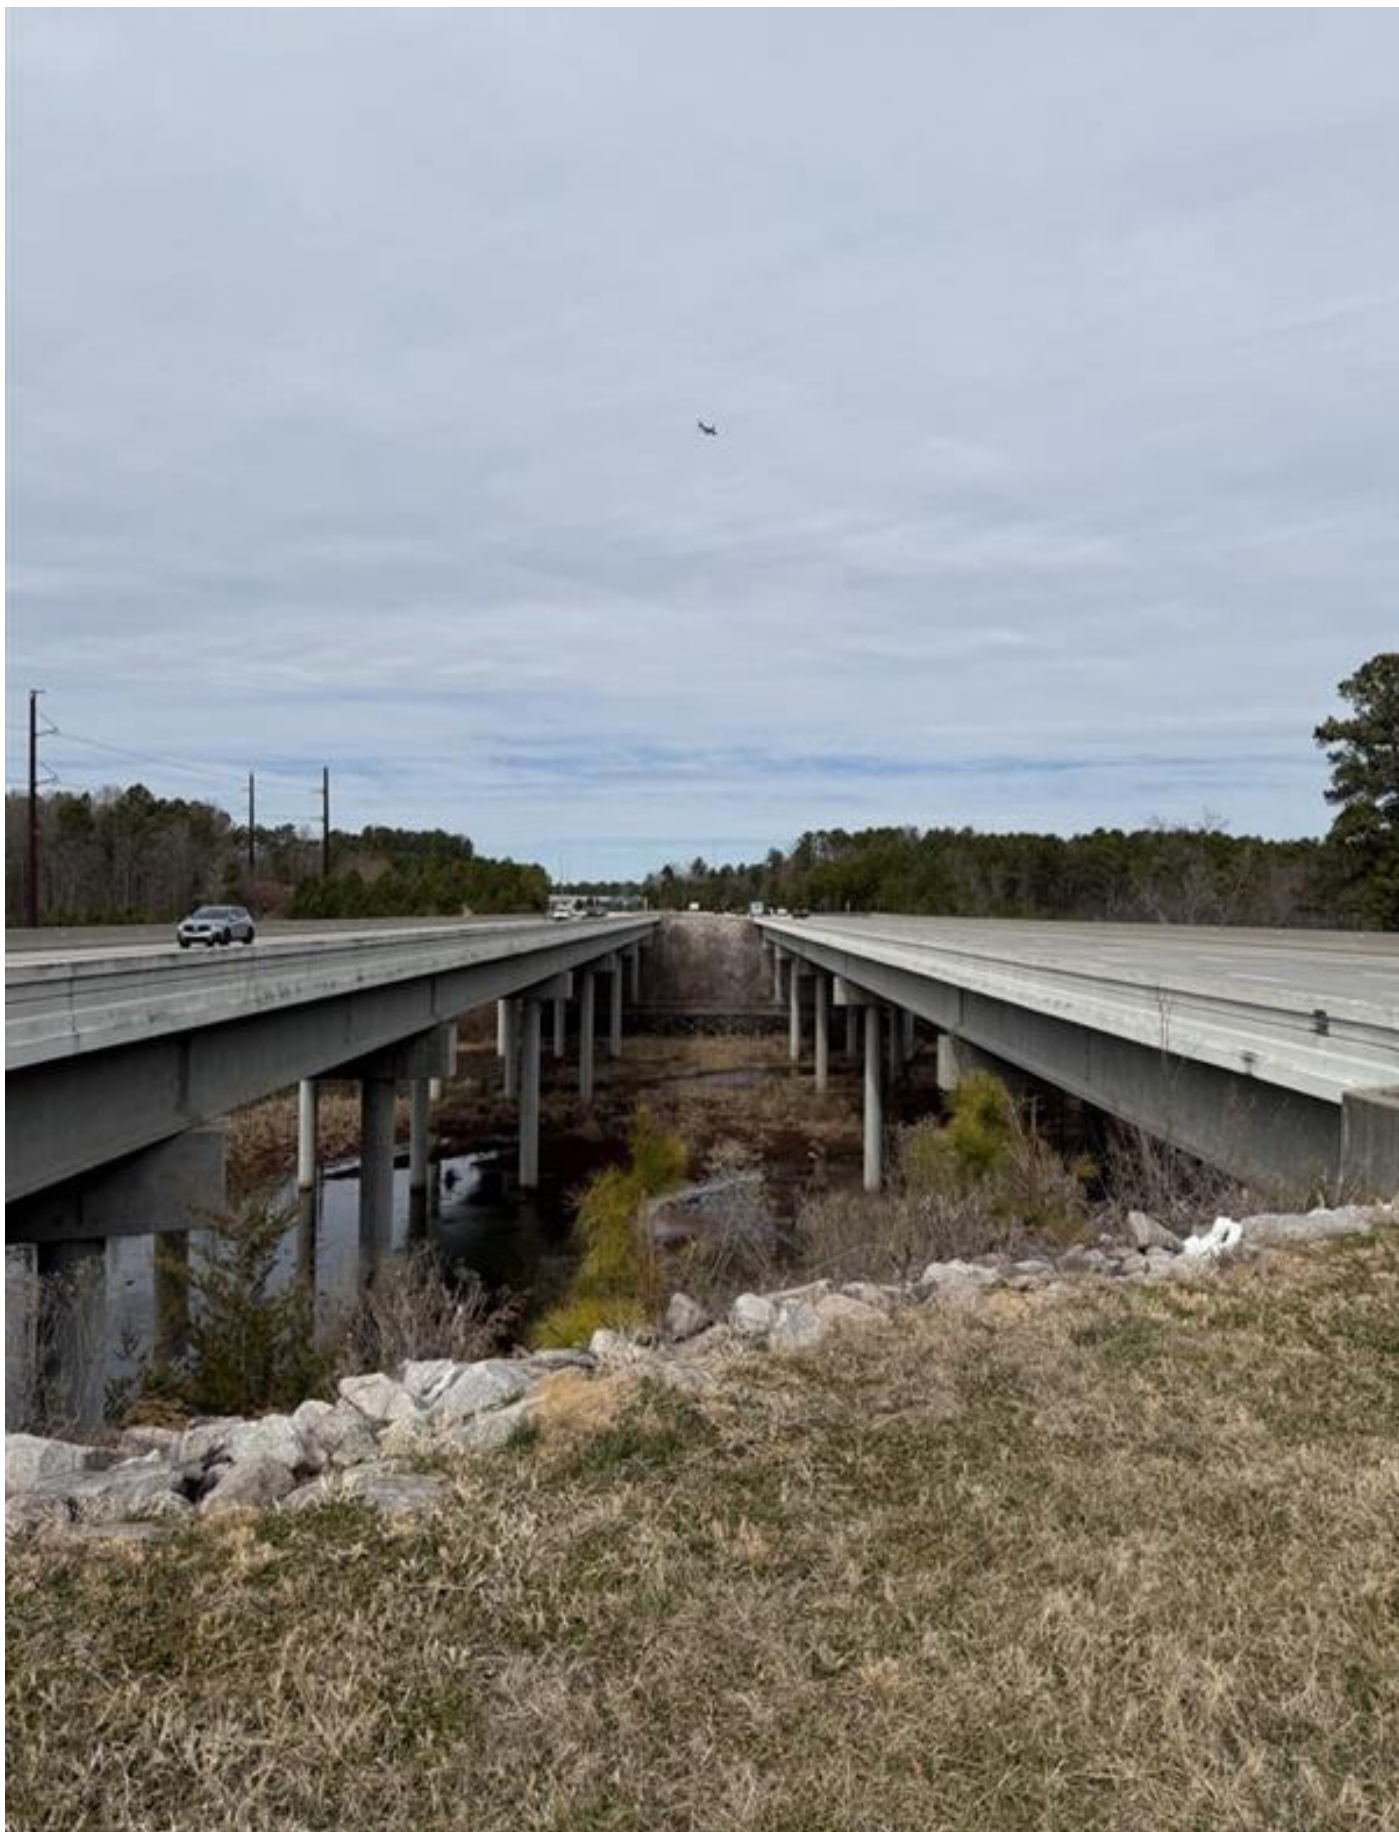
*Figure 6: N.C. 540 over White Oak Creek*

There were a total of nine (9) crashes recorded within the hot spot associated with this bridge.

Assessment conditions indicate a large, open bridge with no identified barriers to passage. The structure spans a wide, meandering wetland; dry bank continuity through the crossing could not be confirmed given the wetland character of both the bank and stream channel. Geese were observed using the crossing at the time of assessment, and no road-kill was present. The crossing width and absence of barriers suggest clear functional passage. Whether dry terrestrial passage is consistently available for species that require it remains uncertain and would benefit from follow-up

monitoring. Built in 2012 and currently in good condition, the structure is not approaching a maintenance or replacement threshold in the near term, though its condition warrants monitoring as part of NCDOT's standard inspection cycle.

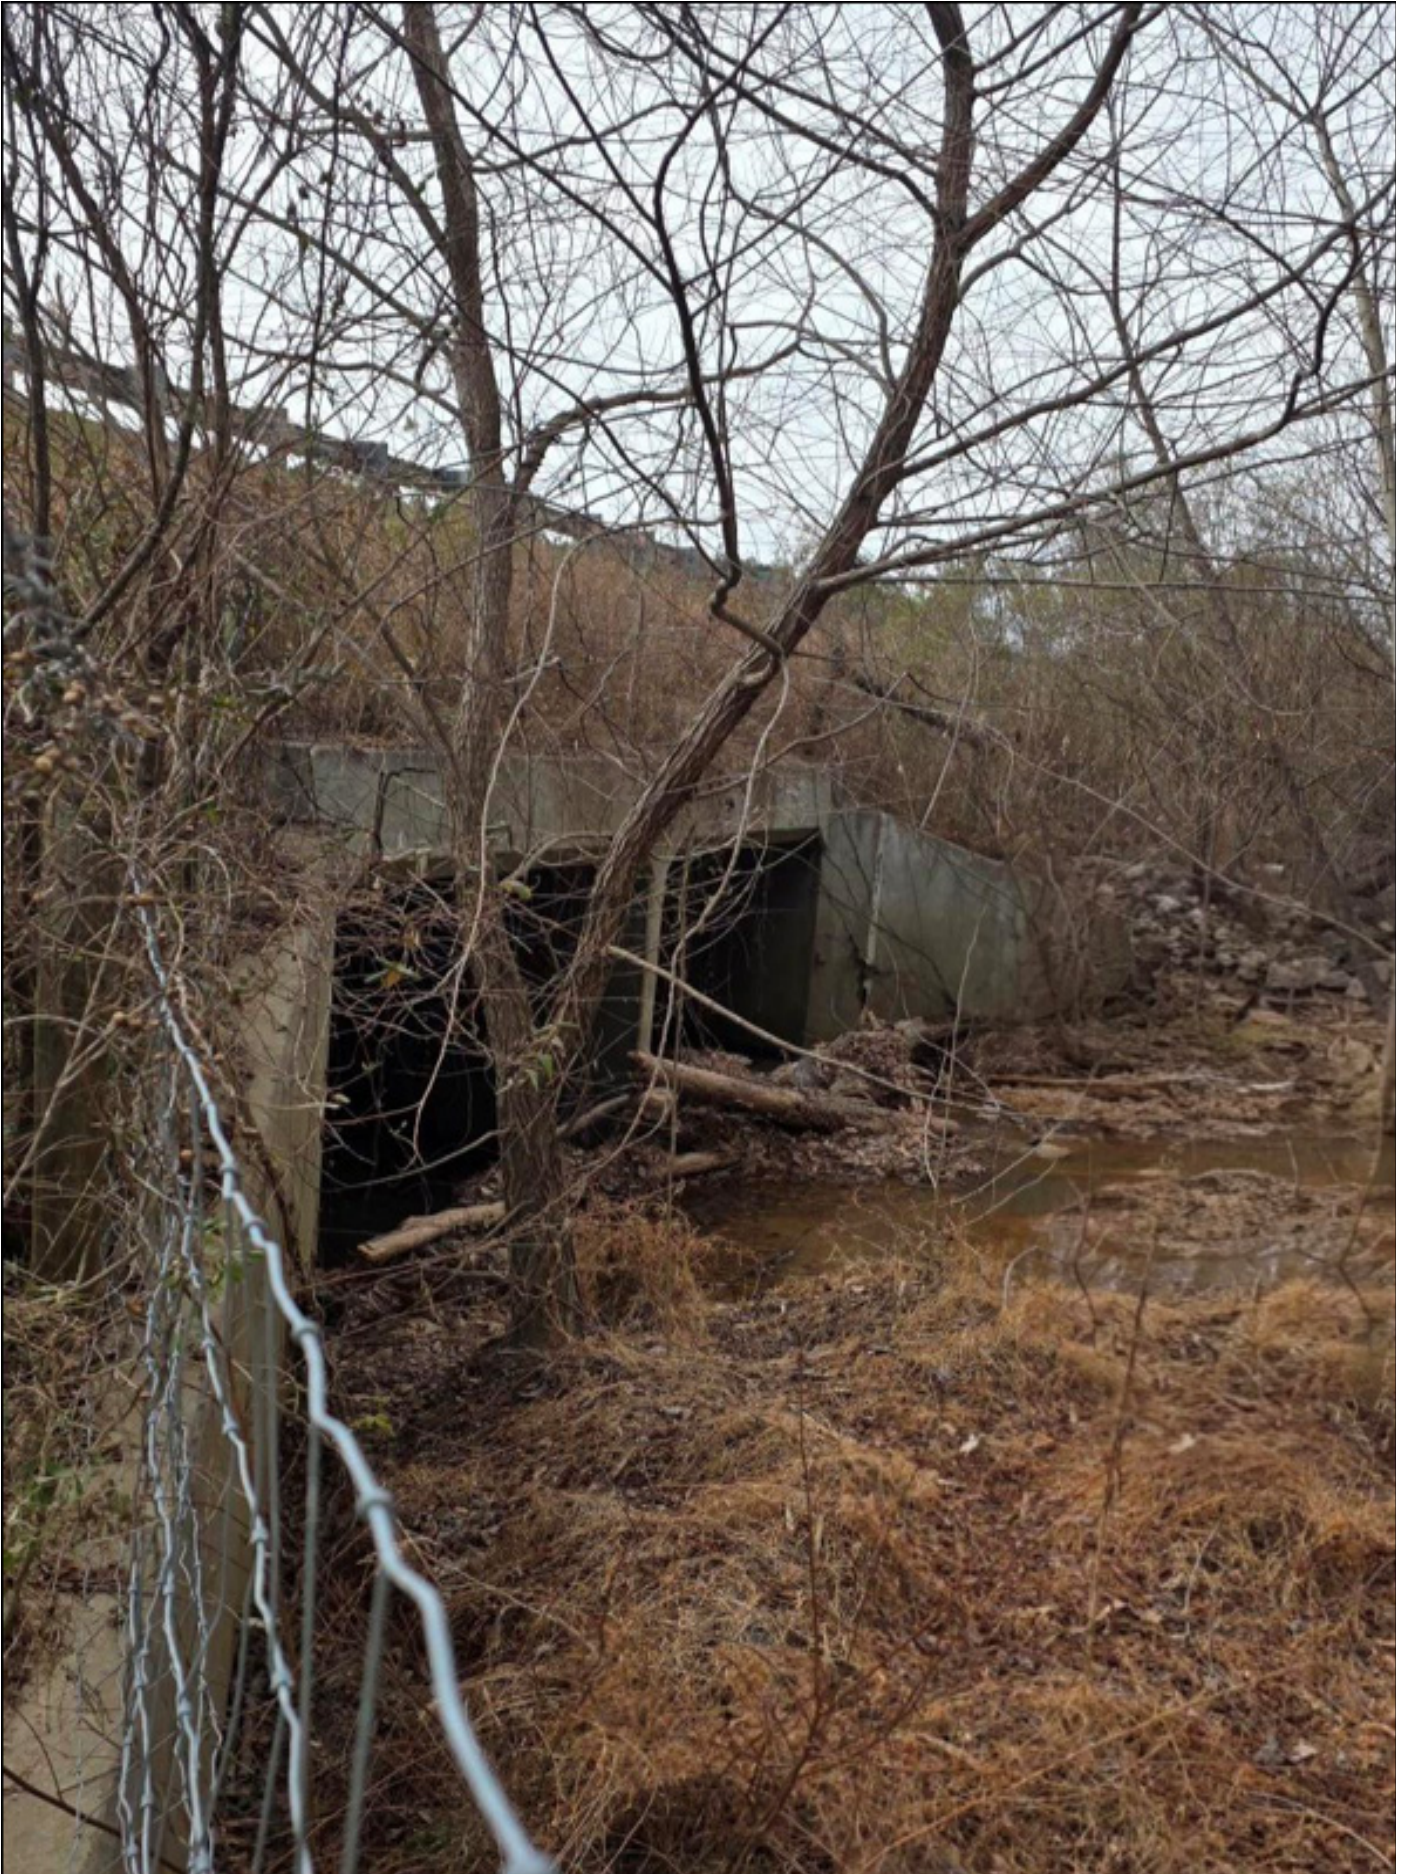
*Figure 8: Little Branch Creek Culvert*

likely dries out seasonally. Deer tracks and beaver activity were documented, confirming wildlife presence in the corridor. Structure age and condition are not available in the NCDOT database, and no STIP project is currently programmed, meaning a near-term construction window is not anticipated. Absent a programmed project, advancing improvements at this site would require a stand-alone project submission or coordination with NCDOT's maintenance division.

Assessment conditions indicate a medium culvert with several barriers limiting passage effectiveness. Standing water, debris, and rip-rap were observed, and no continuous dry bank was present through the structure. A dry path was present but tied into only one bank. The culvert is dammed on one side and

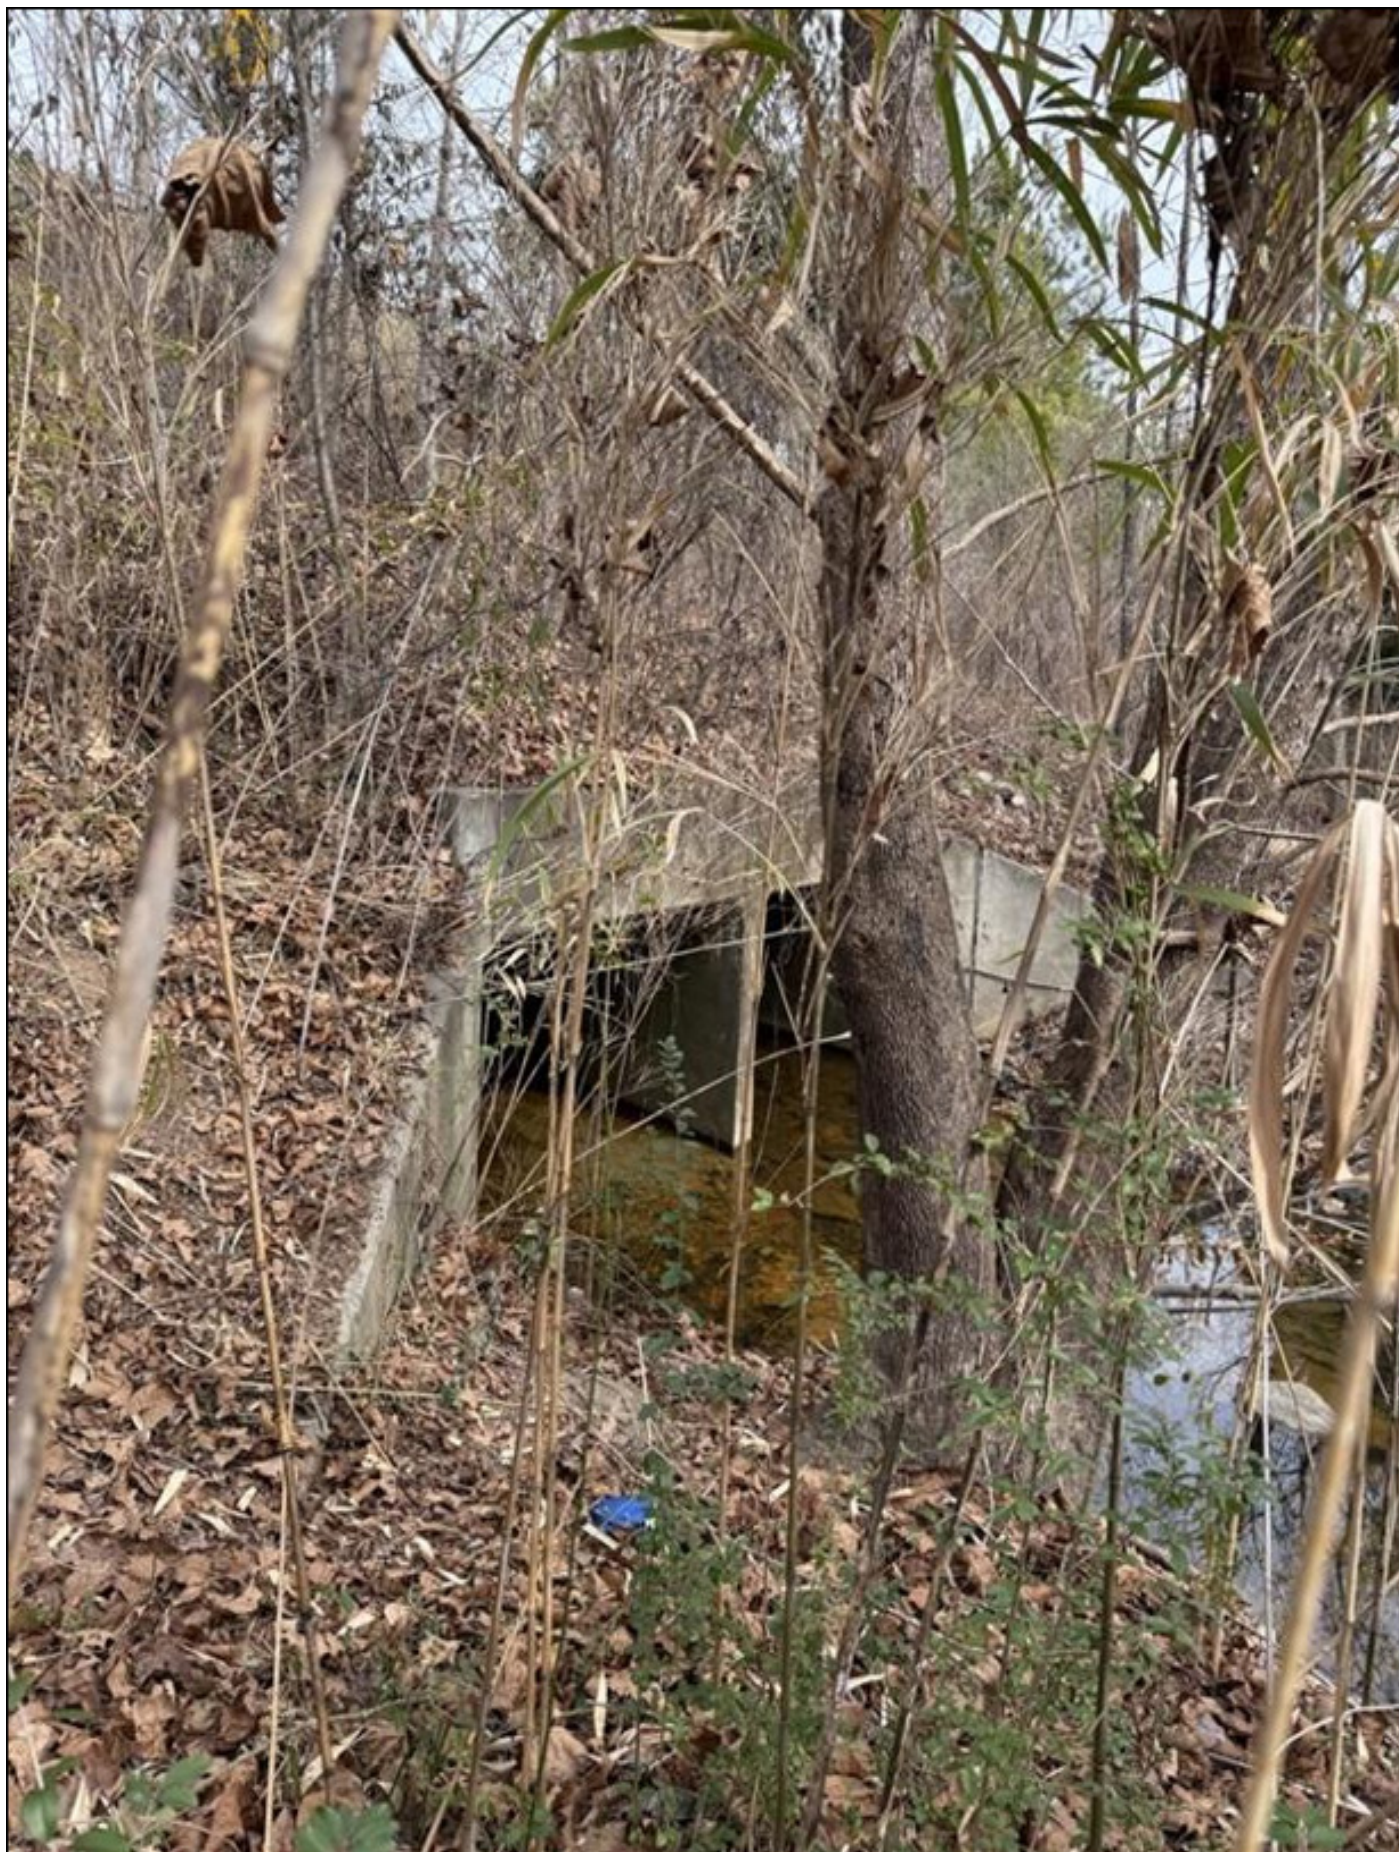
*Figure 10: Big Branch Creek Culvert*

Assessment conditions indicate a medium culvert with significant barriers

to passage. Standing water was present, no continuous dry bank was found, the structure was minimally visible through to the other side, and no dry path was tied into either bank. Rip-rap covers both the bank and stream channel. Wildlife use of the crossing could not be confirmed, though beaver activity was observed nearby. The structure is located within the NCDOT Non-NBIS dataset, specifically listed as BP-092-4483 and BP-092-4525. NCDOT Division 5 has provided structure codes of E4483 and E4525. There is no STIP project currently programmed for this location. The interchange context and uniformly poor passage conditions across multiple culverts suggest

this site and its neighboring structures may warrant a corridor-level treatment strategy rather than improvement to a single opening. Without a programmed project, coordination with NCDOT Division 5 would be the likely path to advancing any treatment consideration.

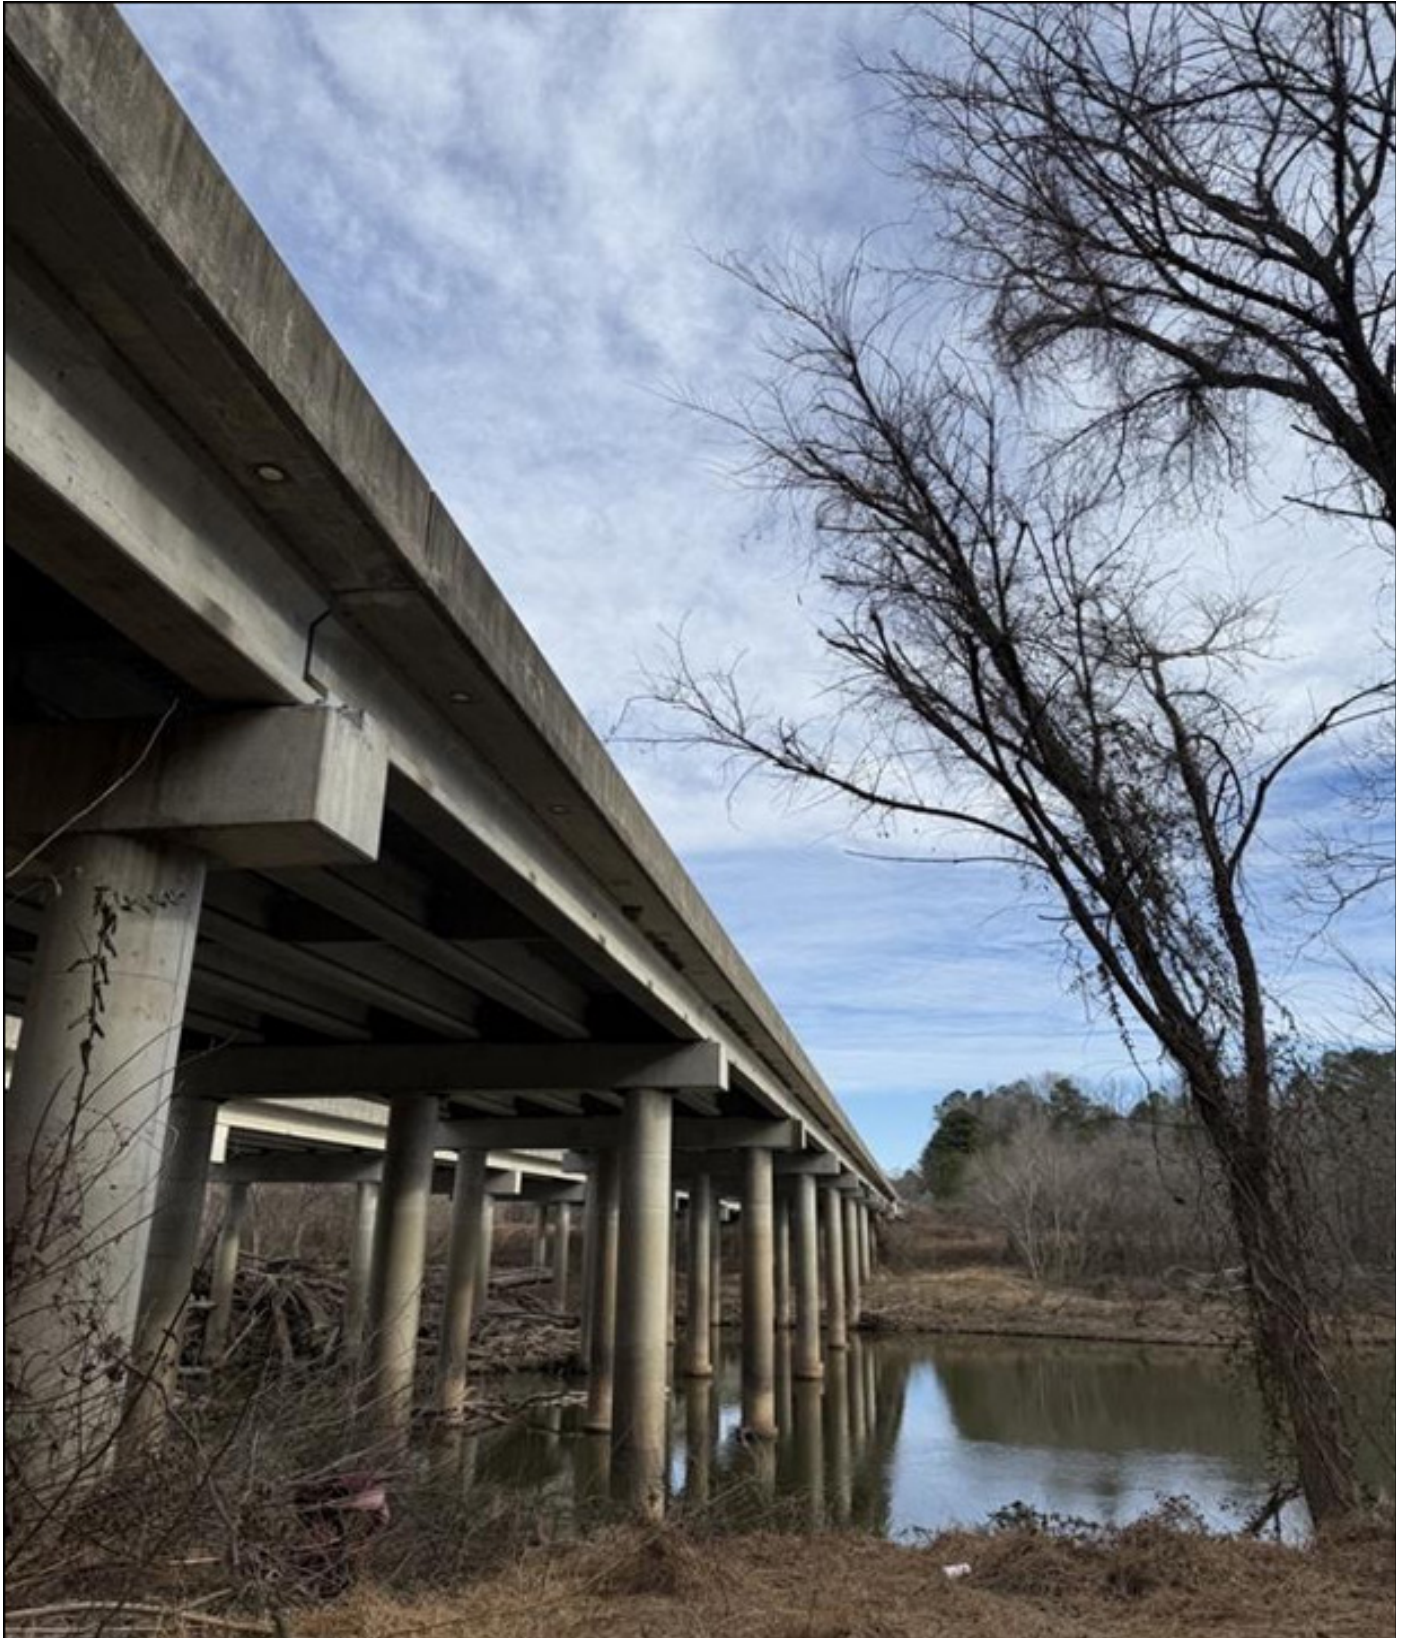
*Figure 11: U.S. 1 over the Deep River*

Assessment conditions indicate a large bridge with a wide, lightly vegetated path beneath the structure suggesting active passage use. Riprap was the only barrier identified, and no dry bank was confirmed on the assessed side. No roadkill was present. The unobstructed underpass and observed passage conditions make this location one of the stronger candidates among the assessed structures. Both the southbound (180007) and northbound (180477) structures were built in 1997–1998 and

are currently rated in good condition, indicating no near-term replacement is anticipated. Without a programmed STIP project, a standalone submission or coordination with NCDOT Division 8 would be needed to advance treatment. Conditions on the eastern bank, where the Deep River Trail is planned, were not assessed from this approach and require further investigation.

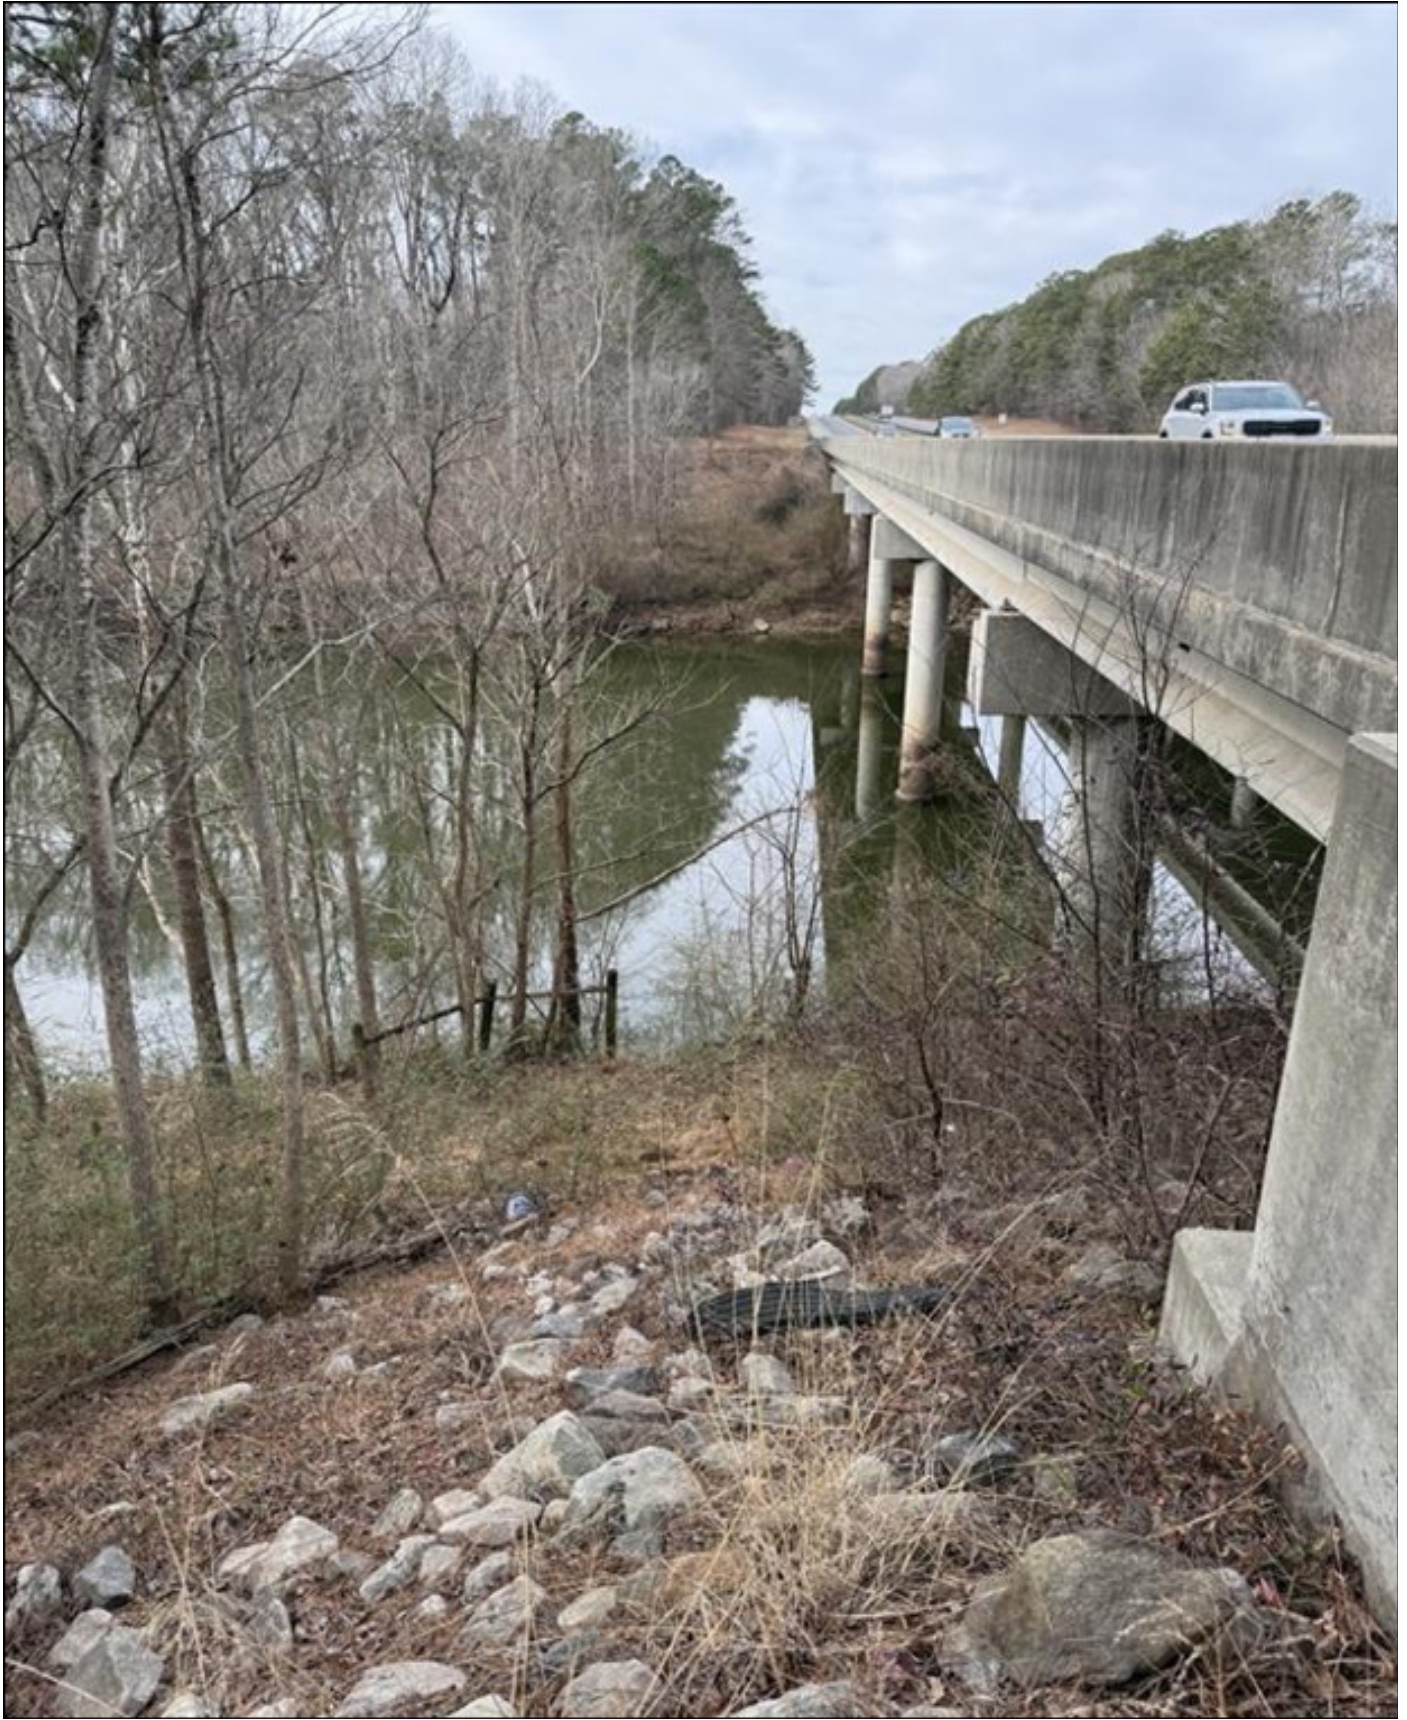
*Figure 13: U.S. 1 over the Haw River*

Assessment conditions on the eastern bank indicate a large bridge with riprap covering the bank and no clear terrestrial passage. No wildlife use was confirmed, though a raccoon roadkill was observed at the time of assessment — direct evidence of WVC risk at this location. Both structures (180053, 180478) were built in 1997–1998 and are currently rated in fair condition. Without a programmed STIP project, a standalone submission or coordination with NCDOT Division 8 would be needed to advance treatment. Conditions on the western bank were not assessed and require further investigation before passage suitability can be fully characterized.

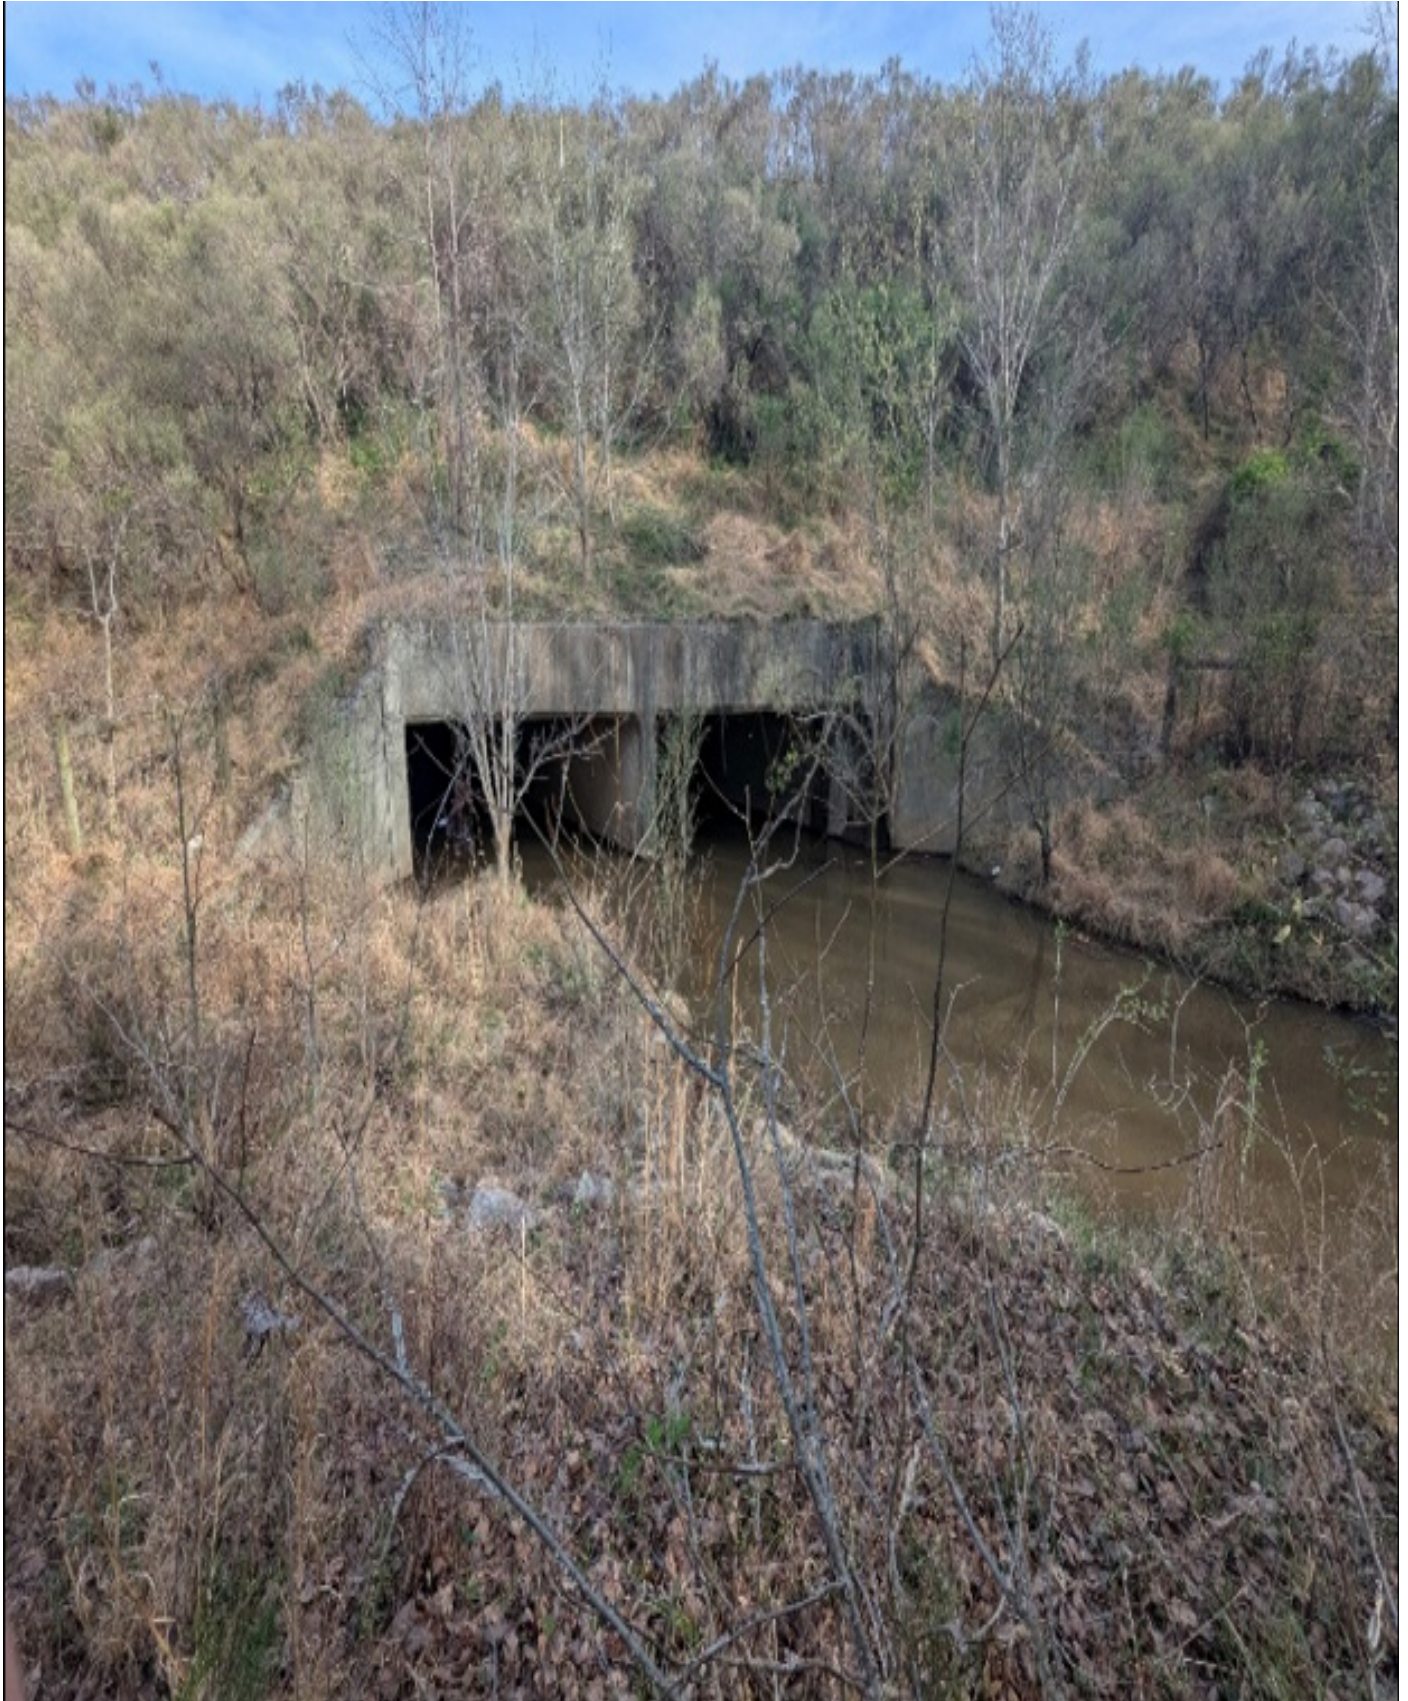
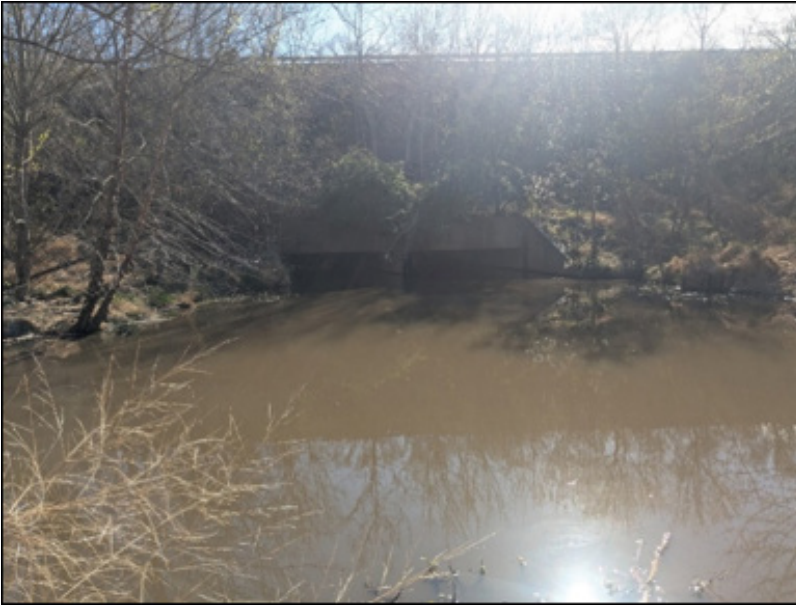
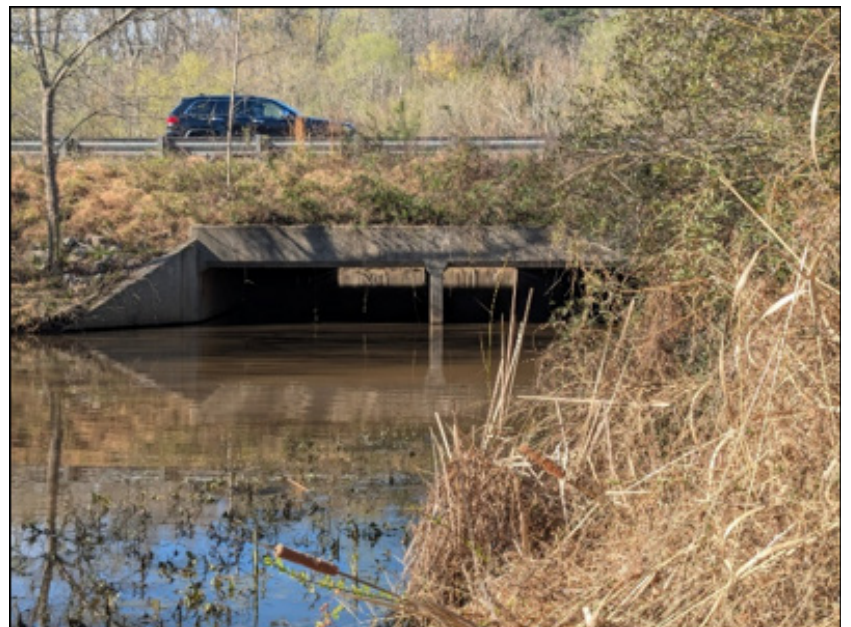
The defining physical condition at this site is the influence of Holts Pond, whose water level is sufficient to submerge all three culvert openings by a minimum of approximately three feet. This condition persists upstream and connects to the unrecorded structure on Davis Drive south of NC 540, effectively creating a continuous inundated corridor through the assessment area.

Under these conditions, the standard assessment framework for terrestrial passage — dry bank continuity, substrate visibility, passage width — is not applicable. All three structures are currently accessible only to aquatic and semi-aquatic species. Beaver activity was documented throughout the site,

consistent with the ponded conditions. The three structures were built in 2007 and are rated in good to fair condition.

That determination requires coordination with the pond's managing entity and is beyond the scope of this study. NCDOT Division 5 and NCWRC should be engaged to evaluate whether hydrological conditions are likely to change, whether the unrecorded south Davis Drive structure warrants inclusion in future analysis, and whether any near-term maintenance activity on the three recorded structures could

incorporate passage improvements contingent on pond level management.
