*NORTH FALLS LAKE AREA STUDY*

# Road Safety Audit

**A road safety audit was conducted at Butner-Stem Elementary School. The audit focused on school-related traffic operations and safety impacts to the surrounding area.**

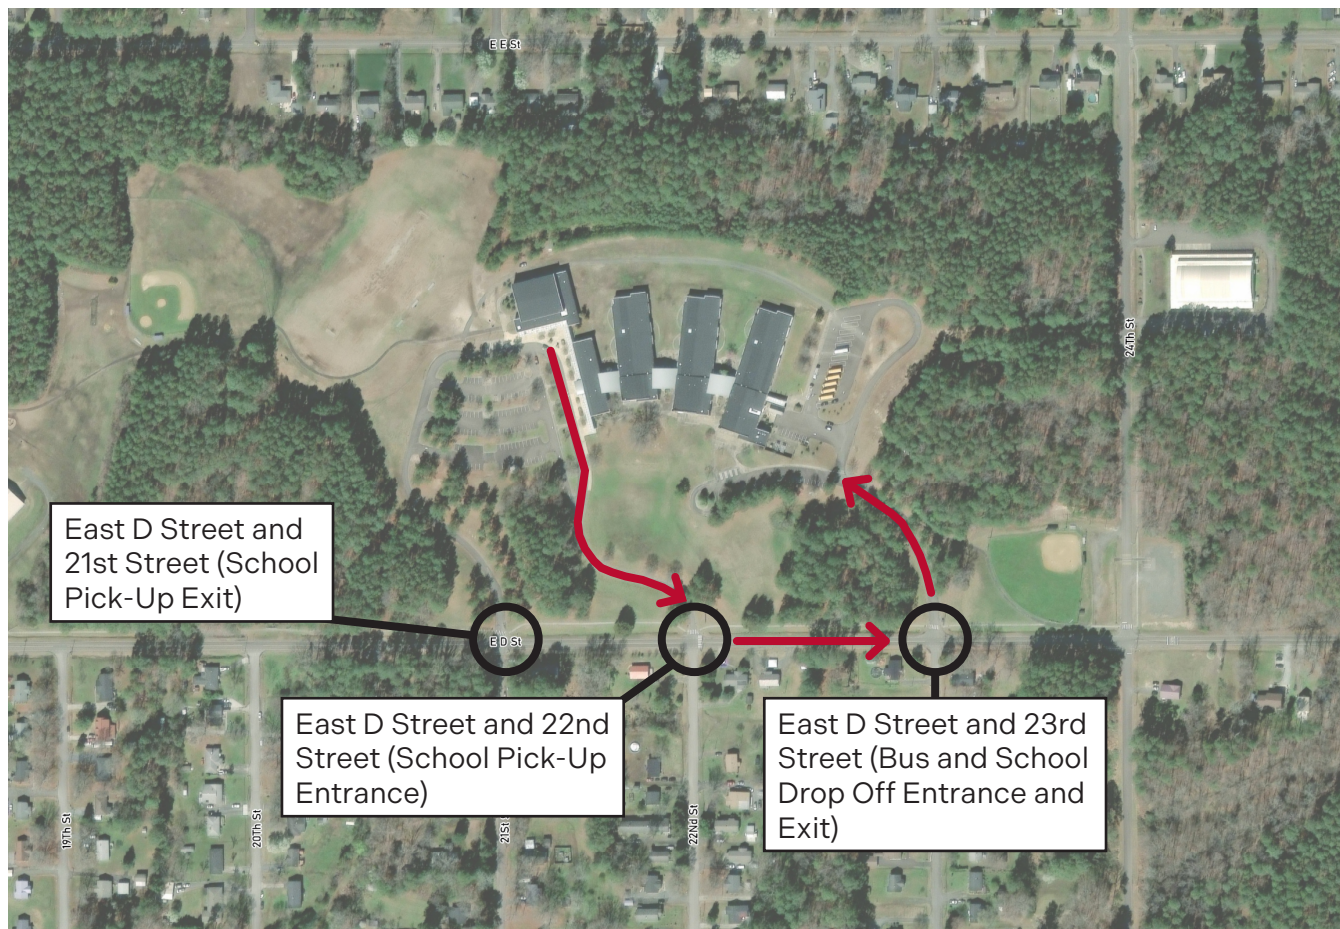
**Figure A. Map of East D Street Corridor**

Figure A illustrates the RSA study limits, the intersections evaluated as part of this assessment, and the pedestrian route observed by the RSA team during field review.

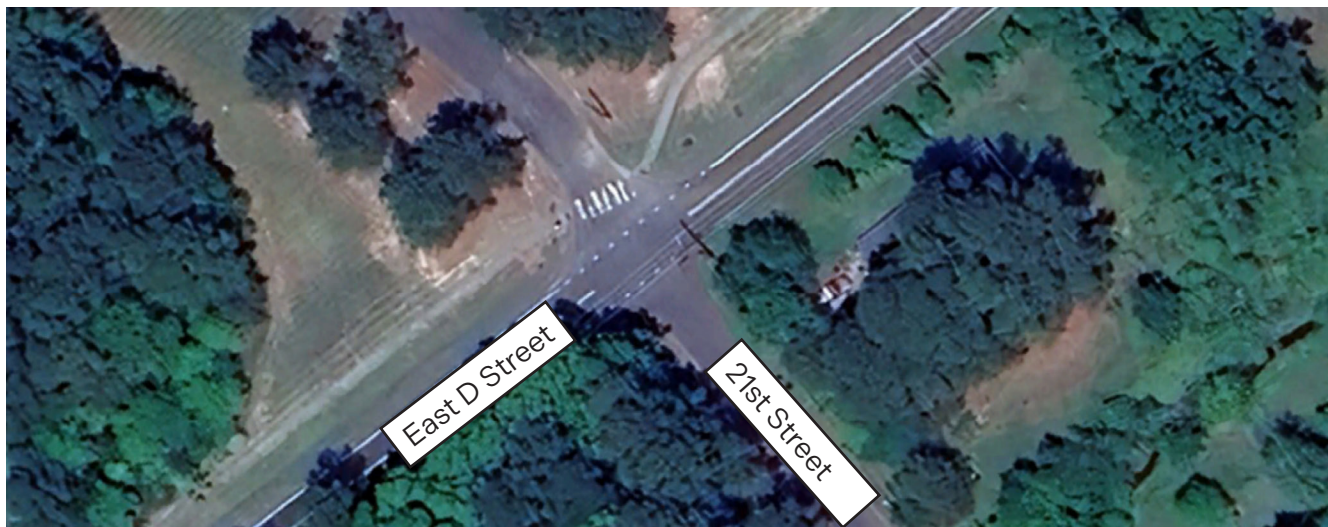
**Figure B. East D Street and 21st Street Intersection**

This is a four-legged intersection, with 21st Street running northwest-southeast and East D Street running southwest-northeast, as shown in Figure B. East D Street has two lanes, no turn lanes, and a posted speed of 35 mph, with nearby 25 mph school-zone reduced-speed signage. Both 21st Street approaches are stop-controlled. The southeastern leg of 21st Street supports two-way operations but does not have any pavement markings to delineate separate lanes. The northeastern leg of 21st Street, which functions as the primary school exit, has a one-way lane heading southeast (towards East D Street). All approaches are asphalt pavement in fair or better condition with paved shoulders along both legs of East D Street and the southeastern leg of 21st Street, which approaches the intersection on an upgrade. The northwestern leg of 21st Street has curb and gutter, and approaches the intersection on a downgrade, contributing to stormwater drainage issues at the bottom of the driveway, as shown in Figure C.

A sidewalk along the northwest side of East D Street crosses 21st Street using a marked crosswalk. Curb ramps that comply with the Accessible Design standards required by the Americans with Disabilities Act (ADA curb ramps) are installed. However, the ramps are skewed relative to the painted crossing. A steep ditch separates portions of the sidewalk from the roadway.

This is a partially stop-controlled intersection, with both approaches to 21st Street being stop-controlled. There are overhead electric poles on both eastern corners of the intersection, with a streetlight attached to the pole in the southeast corner. As indicated earlier, the northwestern leg approaches the intersection on a downgrade, contributing to flooding at the bottom of the driveway. Furthermore, the downhill approach combined with vegetation along both sides of 21st Street reduces sight distance for drivers turning onto East D Street. Stop compliance on 21st Street was observed to be good during the field review, although it was noted that vehicles frequently pulled up past the painted crossing to check for oncoming traffic along East D Street, effectively blocking the crosswalk from being used. One vehicle turning left onto East D Street was observed pulling up next to a vehicle turning right onto East D Street, restricting visibility for the vehicle turning right. The southeastern leg approaches the intersection on a slight upgrade, which may hinder vehicle acceleration from a stopped position as well as reduce the sight distance for stopped vehicles.

- Paint vehicle stop bars at the approaches to East D Street along 21st Street.
- Repaint the crosswalk.
- Consider installing PHB at crosswalk.
- Reduce the lane width for the school driveway at 21st Street using:

- » Painted gore lines (hatching) to discourage cars from pulling up next to each other while preserving space for buses and emergency vehicles.
  - » (Alternatively) install concrete bump-outs to physically restrict vehicles from pulling up next to each other.

- Install "Cross Traffic Does Not Stop" (MUTCD W4-4P) warning plaques to the approaches of 21st Street.
- Realign the sidewalk approaches to the pedestrian crossing to provide a more direct crossing of 21st Street.

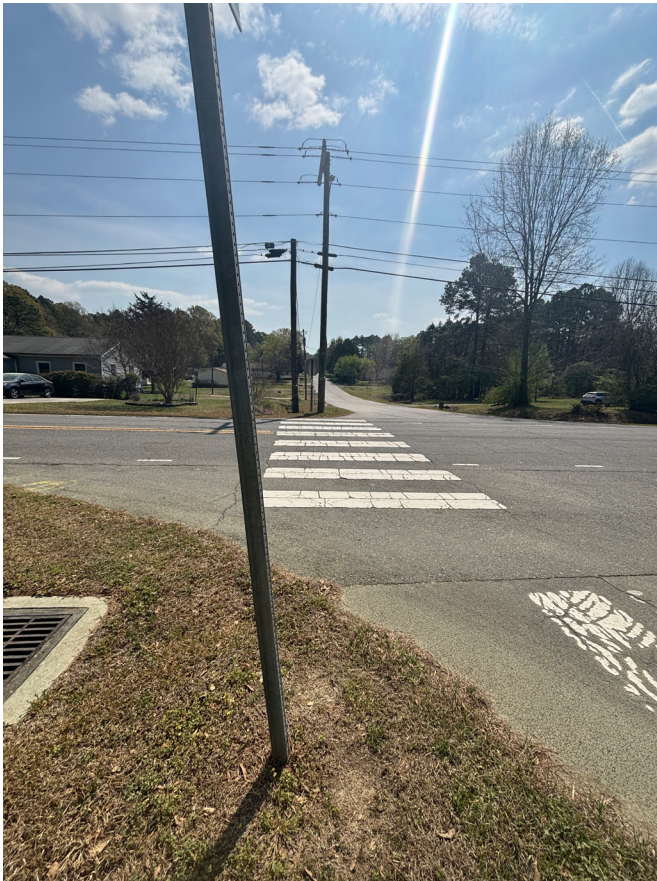
**Figure D. East D Street and 22nd Street Intersection**

This is a four-legged intersection, with 22nd Street running northwest-southeast and East D Street running southwest-northeast, as shown in Figure D. East D Street has two lanes, no turn lanes, and a posted speed of 35 mph, with nearby 25 mph school-zone reduced-speed signage. The southeastern leg of 21st Street is stop-controlled and supports two-way operations but does not have any pavement markings to delineate separate lanes. The northwestern leg of 21st Street is a one-way, northwest bound, lane. All approaches are asphalt pavement in fair or better condition with paved shoulders along East D Street and the southeastern leg of 22nd Street. The northwestern leg of 22nd street, which functions as the primary passenger car entrance to the school campus, has curb and gutter.

A sidewalk present along the northwest side of East D Street is separated from the roadway with a steep ditch. The sidewalk crosses 22nd Street using a painted crosswalk; however, the installed ADA curb ramps are misaligned with the marked crosswalk. Another marked crosswalk is present across the northeast leg of East D Street (see Figure E), but it does not connect to a sidewalk on the southeastern side, instead leading pedestrians toward a roadside ditch.

This is a partially stop-controlled intersection, with the northwest bound approach at 22nd Street being stop-controlled. The southeast corner of the intersection has two overhead electric poles, one of which has an attached streetlight, as well as two signposts (for the pedestrian crossing warning sign and stop sign). This cluster of signage and poles creates a blind spot for northwest bound vehicles on 22nd Street approaching the intersection. Pedestrians are directed toward this same constrained visibility zone via a marked pedestrian crossing from the northeast to the southeast corner of the intersection, further exacerbating the safety concerns associated with this reduced visibility.

The crosswalk does not connect to a sidewalk on the opposite side, instead directing pedestrians into a drainage ditch. Because this intersection is the primary school access and the northwest bound approach is the only stop-controlled movement, the blind spot created by roadside objects poses a heightened pedestrian safety concern. Drivers focused on finding gaps in East D Street traffic may not see pedestrians in the blind spot, and the missing sidewalk connection forces users to walk in the street, ditch, or along adjacent yards.

Angle crashes have occurred near this location, including a reported collision from 2025 involving a school staff member during the morning drop-off period. The blind spot created by the poles seems to be the primary factor contributing to angle crashes at this location. Because drivers must assess multiple conflicting movements under restricted visibility conditions, the likelihood of delayed reactions or misjudged gaps may increase, particularly during periods of high activity. The reduced visibility for drivers combined with the lack of sidewalk connectivity reduces safety and comfort levels for pedestrians.

- Paint vehicle stop bars at the northwest bound approach along 22nd Street.
- Repaint the crosswalk.
- Consider installing PHB at crosswalk.
- Install "Cross Traffic Does Not Stop" (MUTCD W4-4P) warning plaques to the approaches of 22nd Street.
- Realign the sidewalk approaches to the pedestrian crossing to provide a more direct crossing of 22nd Street.
- Reconstruct the southeast bound approach to East D Street to improve stormwater drainage. Again, this would improve safety and lengthen the pavement lifespan but would be costly and difficult to implement considering it would require temporary closure of the main school exit route.
- Relocate the pedestrian crossing placement.
- Relocate the poles in the SE quadrant of the intersection. This would require working with the local utility they are managed by.
- Explore operational adjustments that simplify movements at this access point.

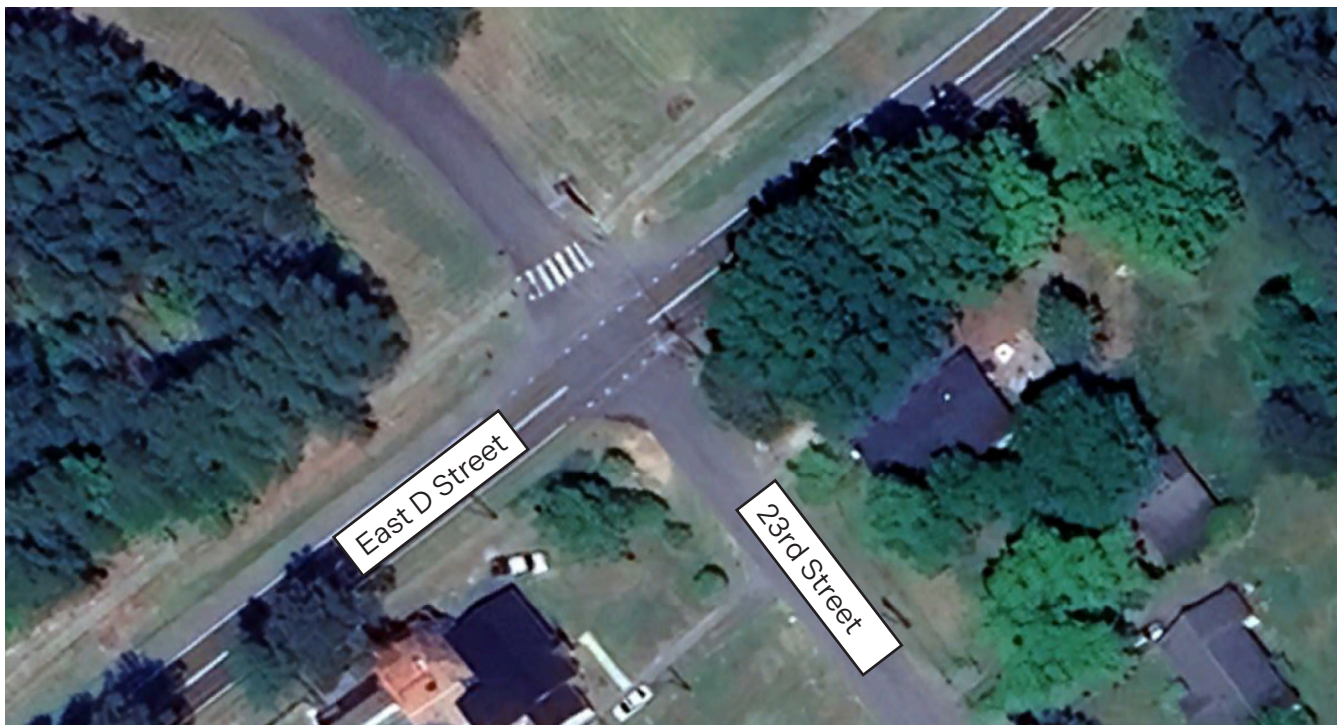
***Figure F. East D Street and 23rd Street Intersection***

This is a four-legged intersection with 23rd Street running northwest-southeast and East D Street running southwest-northeast, as shown in Figure F. East D Street has two lanes, no turn lanes, and a posted speed of 35 mph, with nearby 25 mph school-zone reduced-speed signage. 23rd Street is stop-controlled at both approaches to the intersection and supports two-way operations, but does not have any pavement markings to delineate separate lanes. All approaches are asphalt pavement in fair or better condition with paved shoulders along East D Street and the southeastern leg of 23rd Street. The northwestern leg of 23rd street, which functions as the primary bus access to and from the school campus, has curb and gutter.

A sidewalk is present along the northwest side of East D Street, separated from the road by a steep ditch. The sidewalk crosses 23rd Street using a painted crosswalk with ADA curb ramps.

This is a partially stop-controlled intersection, with both approaches to 23rd Street being stop-controlled. There are overhead electric poles on both eastern corners of the intersection, with a streetlight attached to the pole in the southeast corner. This intersection serves as the primary access point for school buses to and from the school campus, to avoid parent vehicle traffic.

- Install a traffic signal at the intersection to guide vehicle movements, paired with pedestrian signals for each crossing.
- Consider installing PHB for East D Street crossing.
- Paint vehicle stop bars at both 23rd Street approaches.
- Repaint the crosswalks.
- Install "Cross Traffic Does Not Stop" (MUTCD W4-4P) warning plaques to the approaches of 23rd Street.
- Install "Buses Only" (MUTCD AR-162) sign at entrance to northwestern leg of intersection to help preserve the separation from passenger car traffic that allows this intersection to function with fewer conflicts.

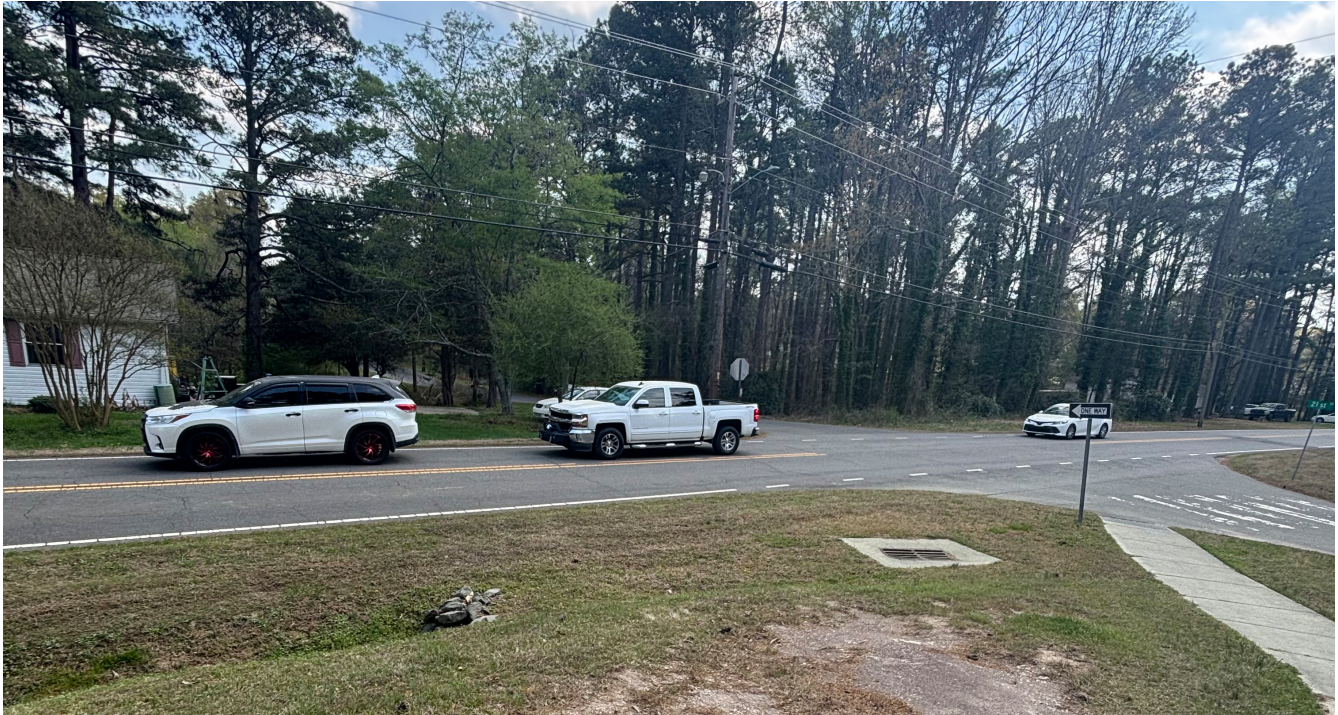
***Figure G. Queues observed along East D Street (looking from the sidewalk towards the intersection with 21st Street) at 2:55 p.m. on March 27th, 2026***

During the afternoon dismissal field visit on March 27th, 2026, vehicle queues generated by school pick up operations were observed along East D Street on both approaches to 22nd Street. Queues began forming at approximately 2:20 p.m., extending to the adjacent 21st Street intersection by 2:55 p.m. (see Figure G), and dissipating by 3:05 p.m. Because East D Street only has one lane in each direction, the queued vehicles restrict through traffic movement for approximately 45 minutes in the afternoon. A queued vehicle was observed partially blocking the 21st Street intersection for a portion of the field visit, indicating that school related queues may also reduce access for cross-street traffic during arrival and dismissal periods.

Drivers seeking to continue through the East D Street corridor were observed crossing the double yellow centerline to pass stopped vehicles. This behavior increases the potential for sideswipe collisions, as drivers bypassing queues must cross the double yellow line three separate times, with a particularly small available area at the second centerline crossing between opposing queues at 22nd Street. Furthermore, such maneuvers increase the risk of head on conflicts, especially given the absence of control measures that discourage simultaneous attempts by opposing vehicles.

In the absence of stop control along East D Street, acceptable operation during dismissal depends on queued vehicles stopping far enough upstream of 22nd Street to maintain a pass-through gap at the intersection. The school principal noted that traffic cones are used at the start of the school year to communicate preferred stopping locations; however, this approach requires drivers to remember and continue to follow temporary instruction year-round. This also makes the dismissal process especially confusing for first-time pick-up drivers, such as relatives. If one of these unfamiliar vehicles queues into the limited gap, through traffic may be forced to stop or make passing maneuvers near the intersection, increasing the potential for conflicts.

Because the queuing pattern relies on informal stopping behavior rather than clearly defined traffic controls, drivers must interpret conditions in real time, which was observed to cause hesitation, illegal maneuvers, or last minute route changes.

- Construct turn lanes to contain queues entering the school driveway.
- Restrict school traffic queuing to 21st Street, which was observed to have significantly less through traffic. It would be important to ensure 21st Street is long enough to contain the number of vehicles queued.
- Instruct school-related traffic to queue in school driveway/parking lot provided there is enough room to operate dismissal safely.
- Install electronic warning signs upstream of 22nd Street and East D Street intersection to encourage non-school traffic to use a detour. Consider installing stop bars and signs along the East D Street approaches to 21st Street to ensure adequate space between opposing queues is maintained.
