# WILDLIFE CROSSING STUDY

Cape Fear River Basin

White Oak Creek at N.C. 540 (2026)

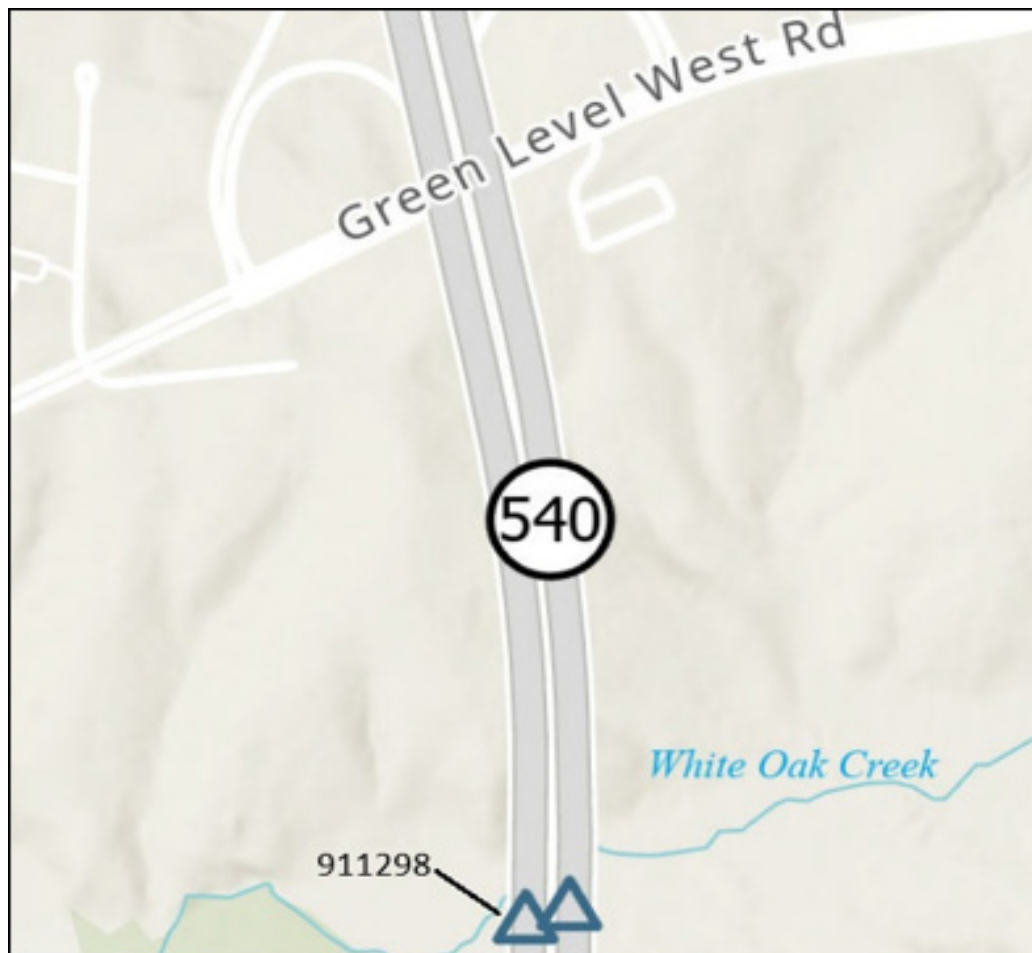
*Figure 7: White Oak Creek Crossing Map*

There were a total of nine (9) crashes recorded within the hot spot associated with this bridge.

Assessment conditions indicate a large, open bridge with no identified barriers to passage. The structure spans a wide, meandering wetland; dry bank continuity through the crossing could not be confirmed given the wetland character of both the bank and stream channel. Geese were observed using the crossing at the time of assessment, and no road-kill was present. The crossing width and absence of barriers suggest clear functional passage. Whether dry terrestrial passage is consistently available for species that require it remains uncertain and would benefit from follow-up

monitoring. Built in 2012 and currently in good condition, the structure is not approaching a maintenance or replacement threshold in the near term, though its condition warrants monitoring as part of NCDOT's standard inspection cycle.

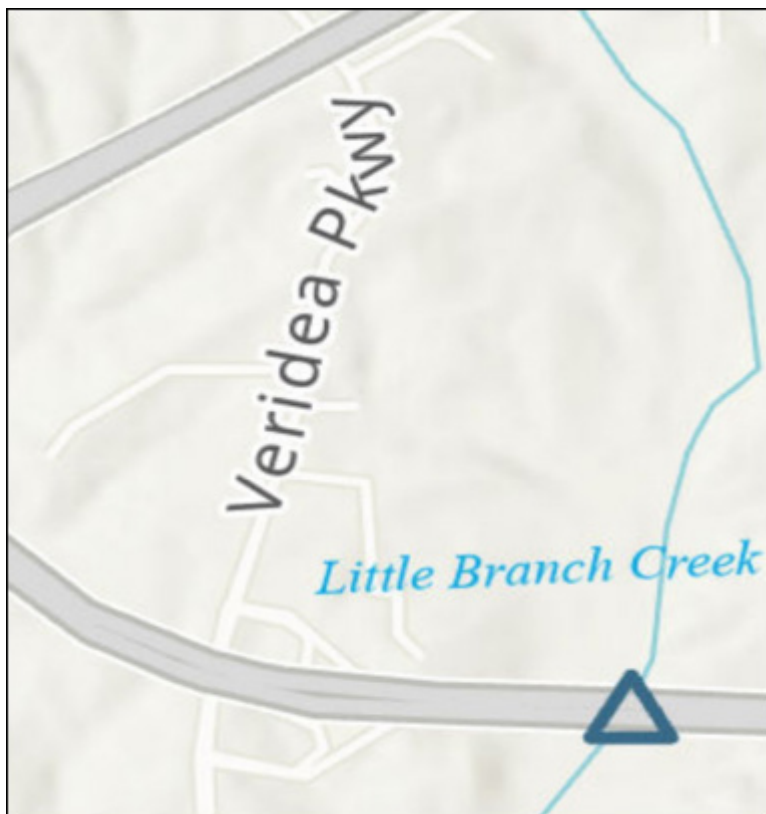
*Figure 9: Little Branch Creek Map*

likely dries out seasonally. Deer tracks and beaver activity were documented, confirming wildlife presence in the corridor. Structure age and condition are not available in the NCDOT database, and no STIP project is currently programmed, meaning a near-term construction window is not anticipated. Absent a programmed project, advancing improvements at this site would require a stand-alone project submission or coordination with NCDOT's maintenance division.

Assessment conditions indicate a medium culvert with several barriers limiting passage effectiveness. Standing water, debris, and rip-rap were observed, and no continuous dry bank was present through the structure. A dry path was present but tied into only one bank. The culvert is dammed on one side and

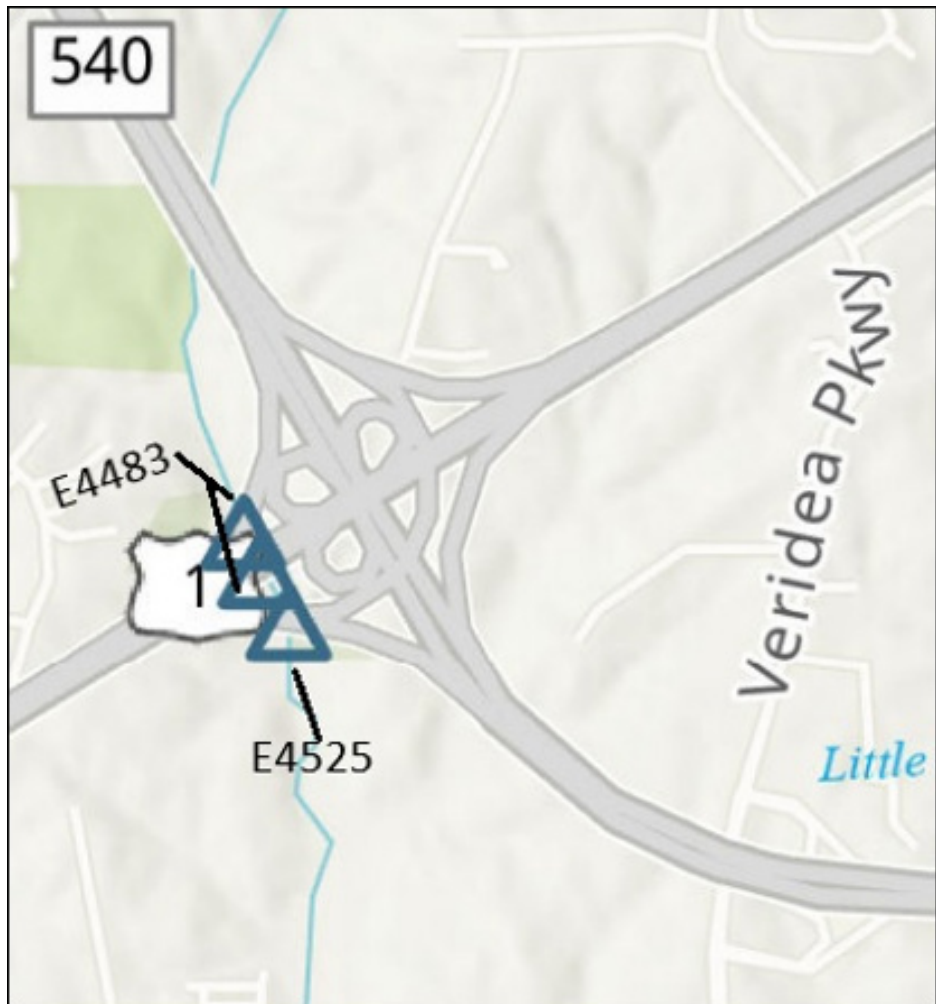
*Figure 11: Big Branch Crossing Map*

Assessment conditions indicate a medium culvert with significant barriers

to passage. Standing water was present, no continuous dry bank was found, the structure was minimally visible through to the other side, and no dry path was tied into either bank. Rip-rap covers both the bank and stream channel. Wildlife use of the crossing could not be confirmed, though beaver activity was observed nearby. The structure is located within the NCDOT Non-NBIS dataset, specifically listed as BP-092-4483 and BP-092-4525. NCDOT Division 5 has provided structure codes of E4483 and E4525. There is no STIP project currently programmed for this location. The interchange context and uniformly poor passage conditions across multiple culverts suggest

this site and its neighboring structures may warrant a corridor-level treatment strategy rather than improvement to a single opening. Without a programmed project, coordination with NCDOT Division 5 would be the likely path to advancing any treatment consideration.

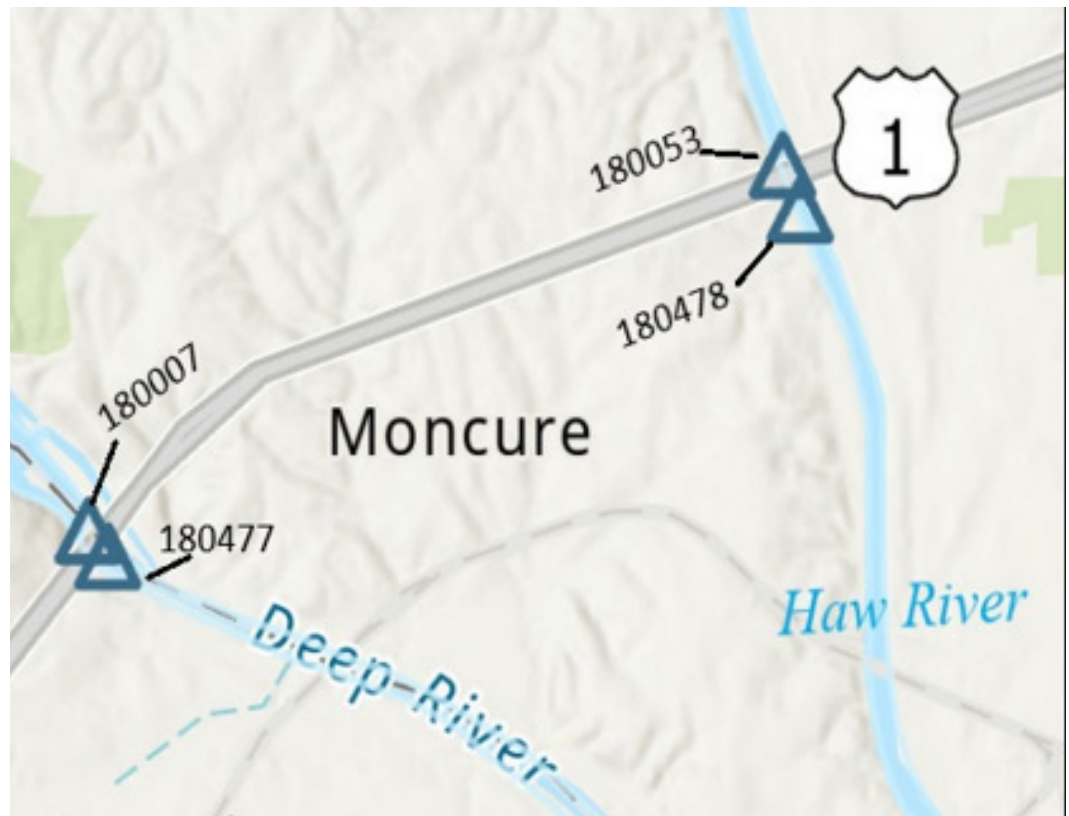
*Figure 12: Deep River and Haw River Crossing Map*

Future Land Use Plan. NCDOT has a planned natural surface trail — the Deep River Trail — along the river’s eastern bank. There were a total of 16 crashes recorded within the hot spot associated with this bridge.

Assessment conditions indicate a large bridge with a wide, lightly vegetated path beneath the structure suggesting active passage use. Riprap was the only barrier identified, and no dry bank was confirmed on the assessed side. No roadkill was present. The unobstructed underpass and observed passage conditions make this location one of the stronger candidates among the assessed structures. Both the southbound (180007) and northbound (180477) structures were built in 1997–1998 and

are currently rated in good condition, indicating no near-term replacement is anticipated. Without a programmed STIP project, a standalone submission or coordination with NCDOT Division 8 would be needed to advance treatment. Conditions on the eastern bank, where the Deep River Trail is planned, were not assessed from this approach and require further investigation.

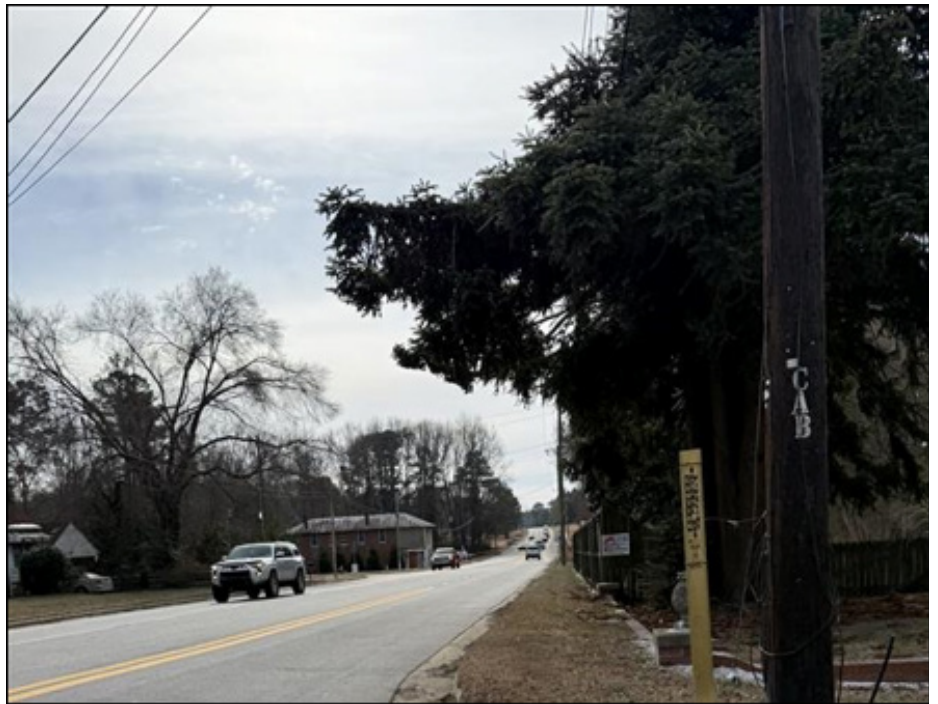
Figure 19: 401 southbound in Chalybeate Springs

The Chalybeate Springs Road and U.S. 401 intersection is located in Chalybeate Springs, an unincorporated community in Harnett County between the Towns of Holly Springs, Angier, and Lillington. The conditions on the date of assessment indicate that there are heavy truck volumes. The speed limit through the corridor is 45 Miles per Hour (MPH).

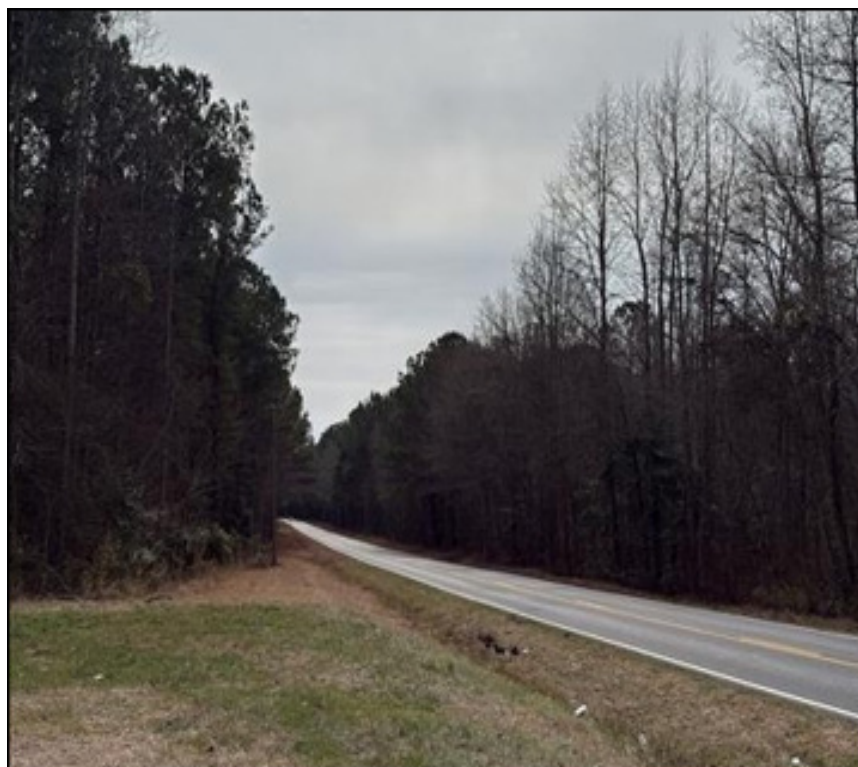
Figure 21: Ross Rd Southbound at Titan Rd Intersection

The Titan Roberts and Ross Road intersection is located in Harnett County between the Towns of Lillington and Erwin, and along the Cape Fear River. The conditions on the date of assessment indicate that there are low traffic volumes. The speed limit is 55 MPH. The landscape surrounding the roadway is relatively flat and relatively forested terrain. There was also no street lighting or animal crossing signage nearby. There were a total of six (6) crashes recorded within the hot spot.

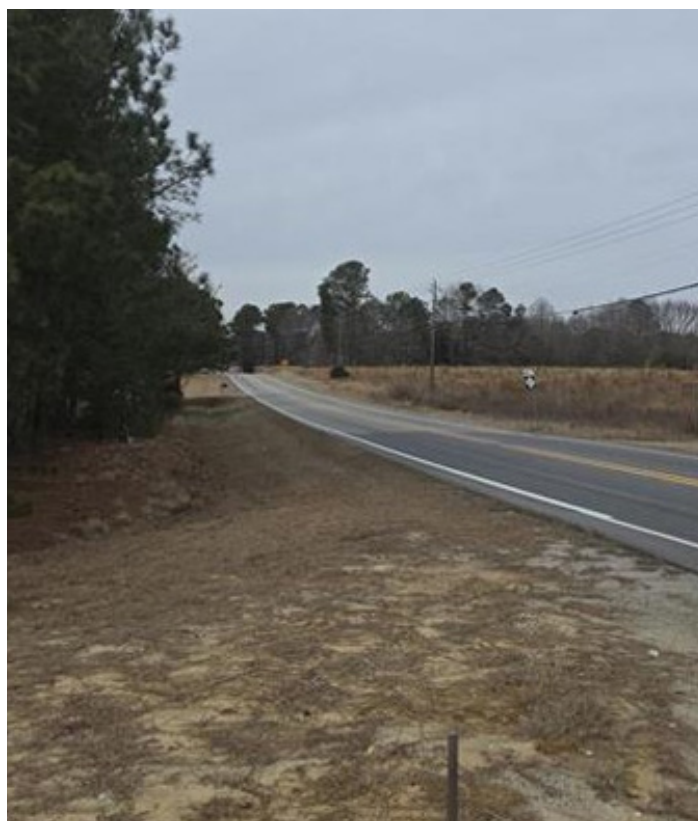
Figure 24: N.C. 27 East at Fairground Rd.

The N.C. 27 East and Fairground Road intersection is located in Harnett County, between the Towns of Benson and Coats. The conditions on the date of assessment indicate that there are moderate traffic volumes with a speed limit of 55 MPH and existing safety investment of a four-way stop with Rapid Flashing Beacons (RFBs). The landscape surrounding the roadway is relatively flat and relatively forested terrain. Also, there is fairly clear visibility, however, there is no street lighting or animal crossing signage nearby. There were a total of nine (9) crashes recorded within the hot spot.

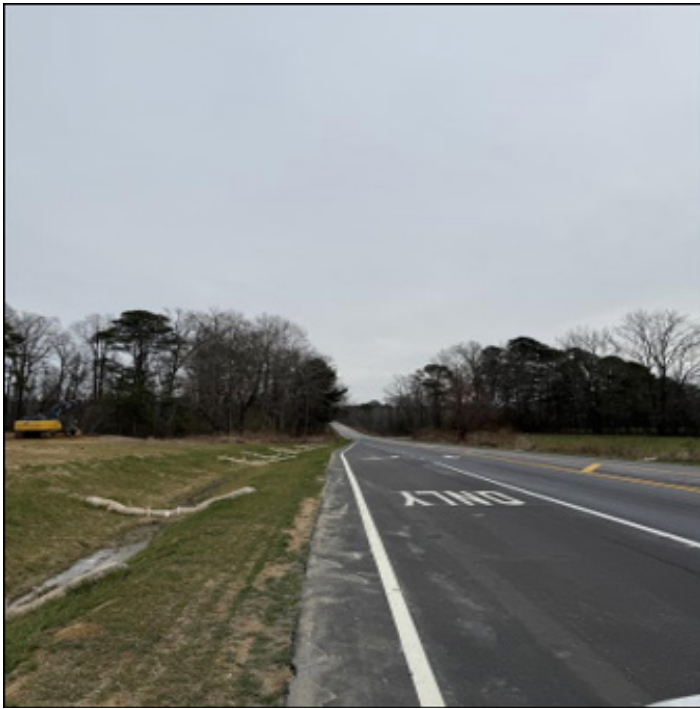
Figure 25: N.C. 27 eastbound toward Delma Grimes Rd.

The N.C. 27 West and Delma Grimes Road intersection is located in the Town of Coats, Harnett County. The conditions on the date of assessment indicate that there are moderate traffic volumes. The speed limit is 55 MPH. The landscape surrounding the roadway is wide-open and flat terrain with sparse trees, and clear visibility. However, there was no street lighting or animal crossing signage nearby. There were a total of 10 crashes recorded within the hot spot.

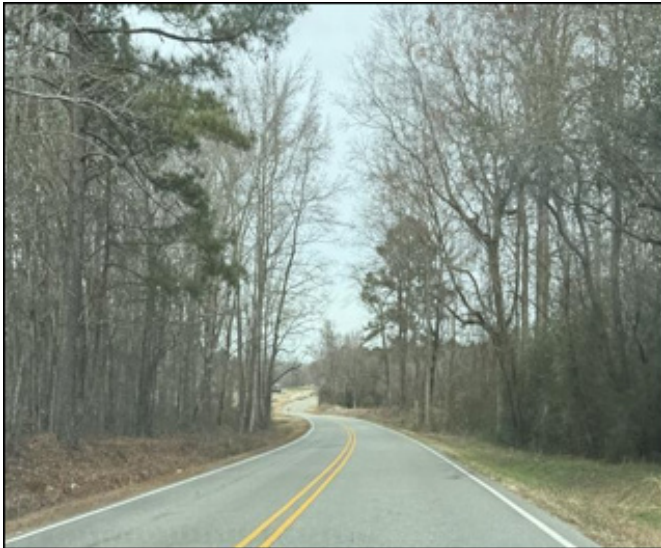
Figure 27: Old Stage Rd. northbound

The HIN hot spot on Old Stage Road is located in the Town of Coats. The conditions on the date of assessment indicate that there are low traffic volumes and the speed limit of the road is 55 MPH. The surrounding landscape is moderately hilly terrain and there is low visibility caused by the horizontal curvature of the roadway. There is also no street lighting or animal crossing signage nearby. There were a total of four (4) crashes recorded within the hot spot.

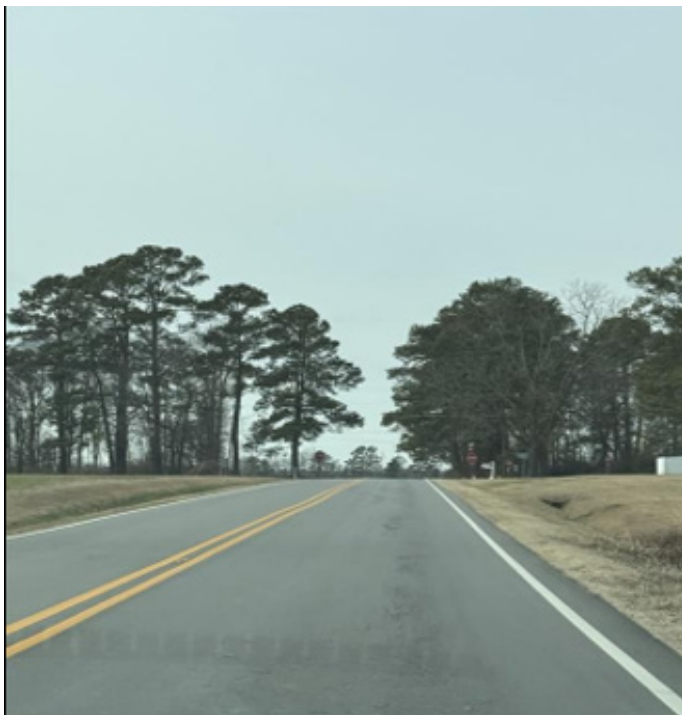
Figure 29: Sheriff Johnson Rd. westbound at Old Buies Creek

The HIN hot spot on Sheriff Johnson Road is located in Harnett County near the Buies Creek community. The conditions on the date of assessment indicate that there are low traffic volumes and the speed limit of the corridor is 55 MPH. Existing safety treatment of a four-way stop with Rapid Flashing Beacons (RFB) has been at the nearest intersection. The surrounding landscape is a relatively open and flat terrain, with sparse trees and clear visibility. There is also no lighting or animal crossing signage nearby. There were a total of five (5) crashes recorded within the hot spot.

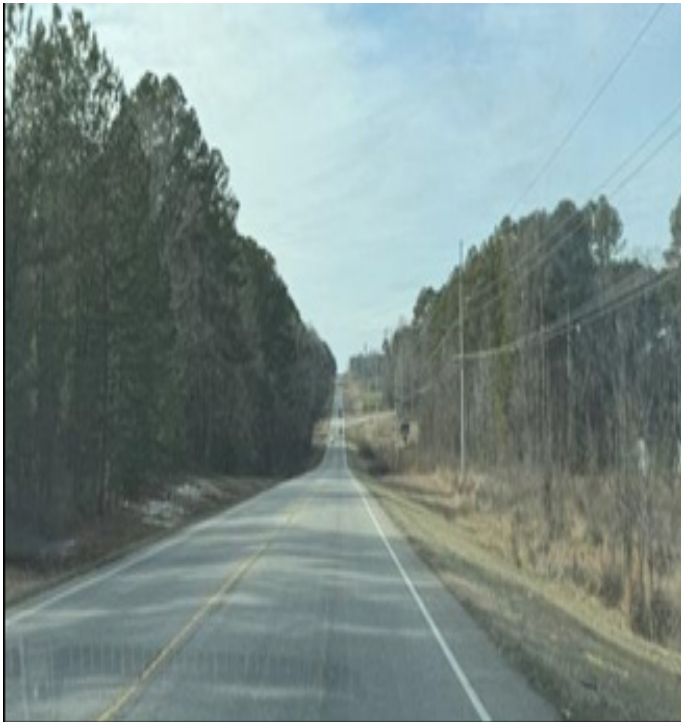
*Figure 31: U.S. Hwy 421 looking west-bound*

The U.S. Highway 421 and Sloan Road intersection is located in Harnett County, roughly 12 miles from the Town of Lillington. The conditions on the date of assessment indicate that there is high traffic and moderate truck volumes, with a speed limit of 55 MPH along the corridor. The surrounding landscape is heavily forested with steep grades in the terrain and there is fairly clear visibility. There is no lighting or animal crossing signage nearby. There were a total of five (5) crashes recorded within the hot spot.

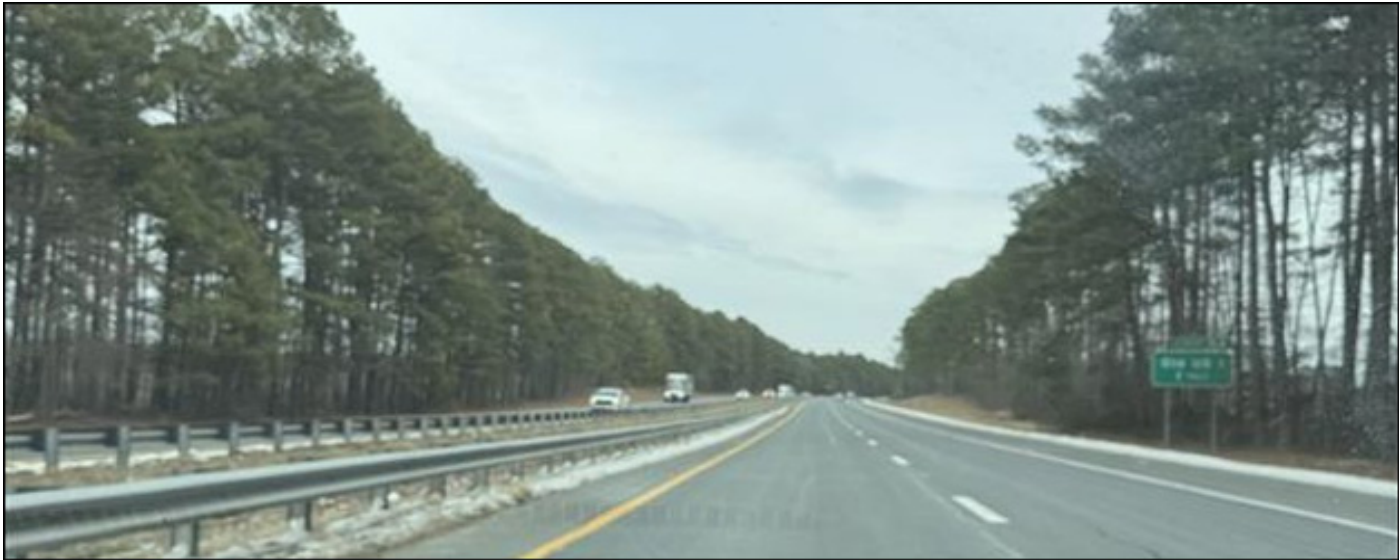
Figure 33: U.S. 1 northbound

There are seven HIN hot spots along U.S. 1 between Old U.S. 1 and Friendship Road near the unincorporated community of New Hill in Wake County. The conditions along the corridor, on the date of assessment, indicate that there are high traffic volumes and the speed limit of the corridor is 70 MPH. The surrounding landscape is heavily forested with moderately steep grades in the terrain, however, there is relatively clear visibility. Also, there is no lighting or animal crossing signage along this section of the corridor. There were a total of 57 crashes recorded within these series of hot spots.

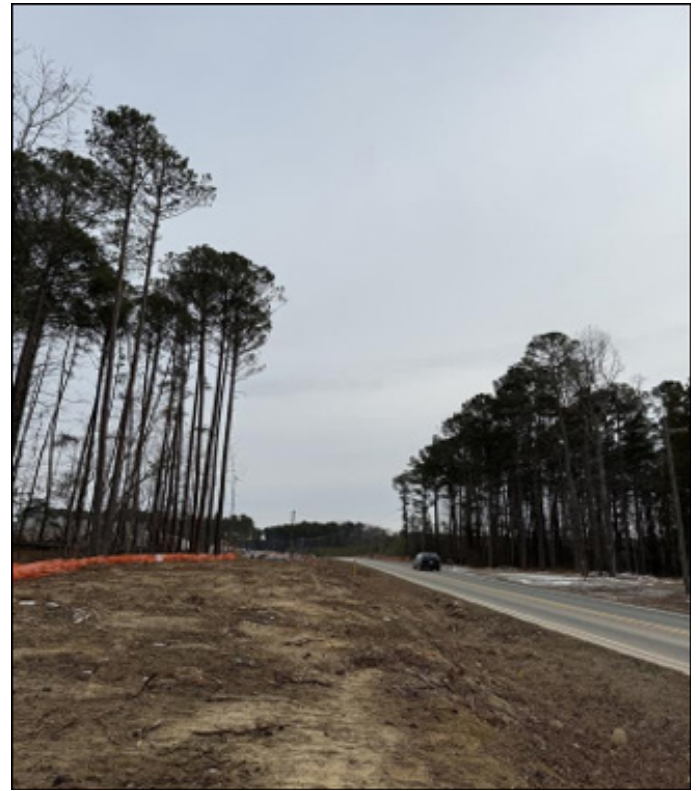
Figure 36: U.S. 751 southbound toward U.S. 64

The HIN hot spot on U.S. 751 is located in the Town of Apex. The conditions on the date of assessment indicate that there are high traffic volumes and the speed limit is 35 MPH. The surrounding landscape is relatively flat terrain and there is low visibility due to the horizontal curvature of the roadway. There is active construction of an industrial development occurring at this location. There is also no lighting or animal crossing signage nearby. There were a total of 10 crashes recorded within the hot spot.

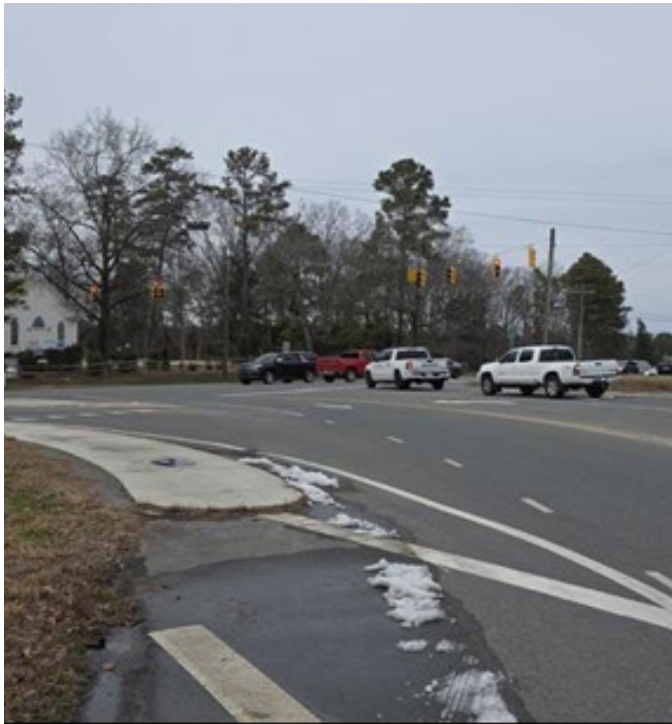
*Figure 38: O'Kelly Chapel facing its intersection with U.S. 751*

The O'Kelly Chapel Road and U.S. 751 intersection within Chatham County. The conditions on the date of assessment indicate that there are high traffic volumes and the speed limit is 45 MPH. The surrounding landscape is relatively forested and flat terrain, with clear visibility from all directions leading to the intersection's stoplight. However, there is some moderate horizontal curvature in the roadway, which may limit visibility at the stoplight. There is no street lighting or animal crossing signage. There were a total of two (2) crashes recorded within the hot spot.

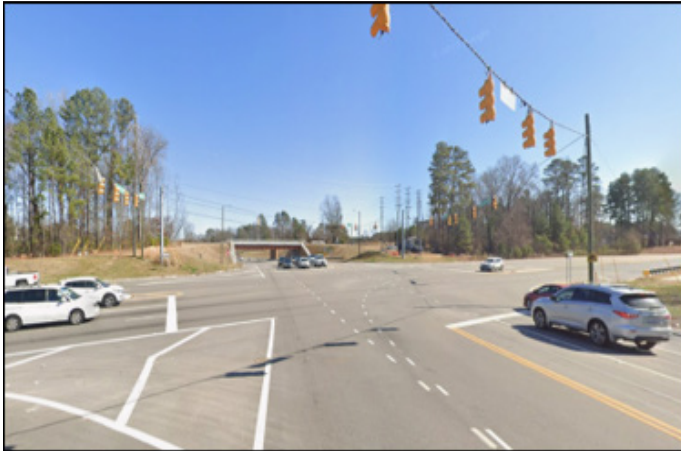
*Figure 40: Carpenter Fire Station Rd. at U.S. Hwy 55*

The Carpenter Fire Station Road and U.S. 55 intersection is located in the Town of Cary. The conditions on the date of assessment indicate that there are high traffic volumes. The speed limit on Carpenter Fire Station Road is 45 MPH and the speed limit of U.S. 55 is 55 MPH. The surrounding landscape is relatively flat and fairly forested. There is also clear visibility, and the intersection is fairly lit by a small number of streetlights. Additionally, the area is surrounded by recently completed development with mid-density apartment complexes and multiple retail buildings. There is no animal crossing signage nearby. There were a total of 18 crashes recorded within the hot spot.
