Wake Transit Plan

Equipment Assessment

TASK 4.2 – EQUIPMENT ASSESSMENT

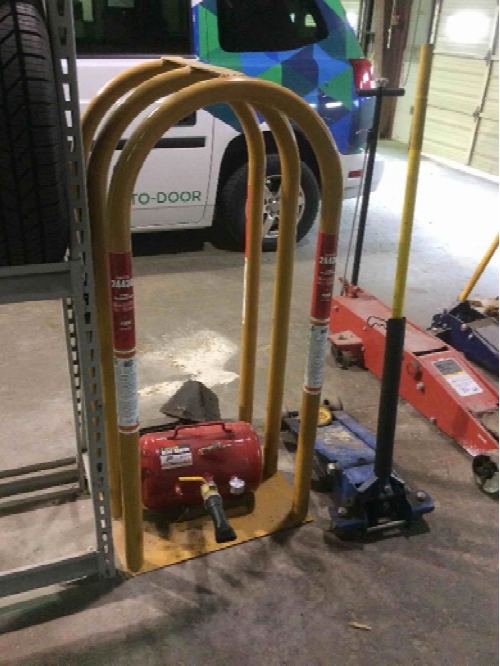
GC.005	Jib Crane	Abell Howe 3 Ton foundation mounted jib crane	Crane is unused and has been decommissioned.	No requirement for a jib crane.	1
GC.006	Bridge Crane	7 ½ ton top running bridge crane	Crane is unused and has been decommissioned.	No requirement for a bridge crane.	1
Tire Repair Area					3.5
GC.007	Heavy Duty Tire Mounter	Heavy duty tire mounter for mounting large bus tires	No visible damage or apparent functional issues.	Perform recommended service as required by the manufacturer to ensure the life expectancy. Relocate.	5
GC.008	Heavy Duty Tire Balancer	Mac Tools wheel balancer with a wheel lift	No visible damage or apparent functional issues. Limited weight and adapter storage.	Replace with a new heavy duty tire balancer when a new facility is constructed.	3
GC.009	Tire Inflation Cage	3-bar tire inflation cage	No visible damage. 5 bars are required for large tires so they are fully protected. No automated air inflation.	Replace with a 5 bar inflation cage with automated air inflation.	3
